Geotechnical reconnaissance of an extensive cover-collapse sinkhole phenomena of 2020-2021 Petrinja earthquake sequence (Central Croatia)

Geotechnical reconnaissance of an extensive cover-collapse sinkhole phenomena of 2020–2021 Petrinja earthquake sequence (Central Croatia)

Earthquake Spectra

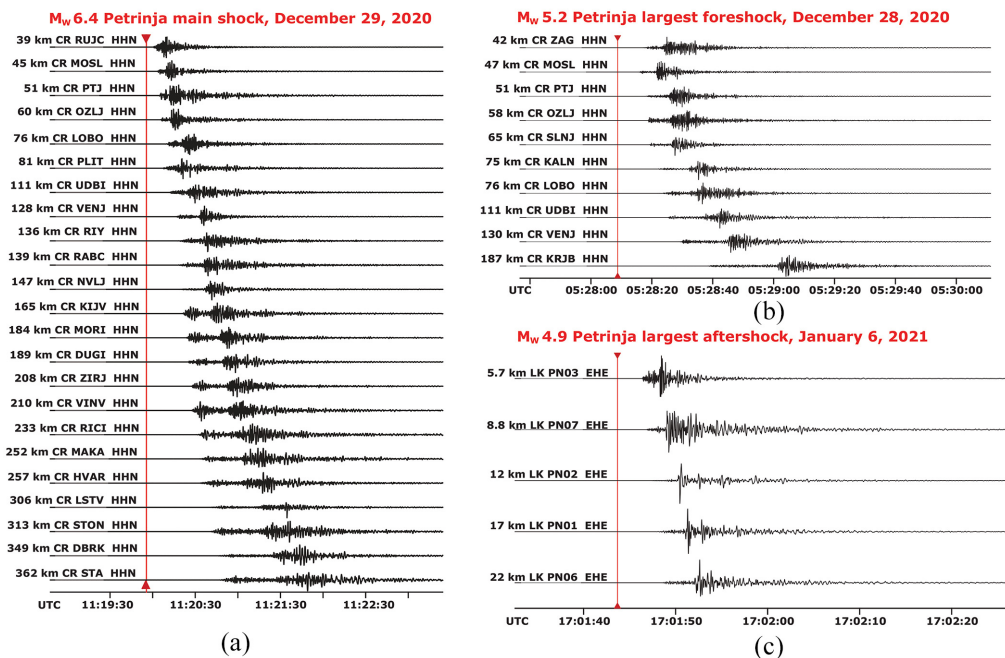
Figure 4. Petrinja earthquake seismograms showing (a) main shock and (b) largest foreshock recorded on permanent seismic stations, and (c) aftershock recorded on temporary stations installed on 5 January 2021 (temporary seismic station LK PN06 was in Mečenčani, for location, see Figure 2).

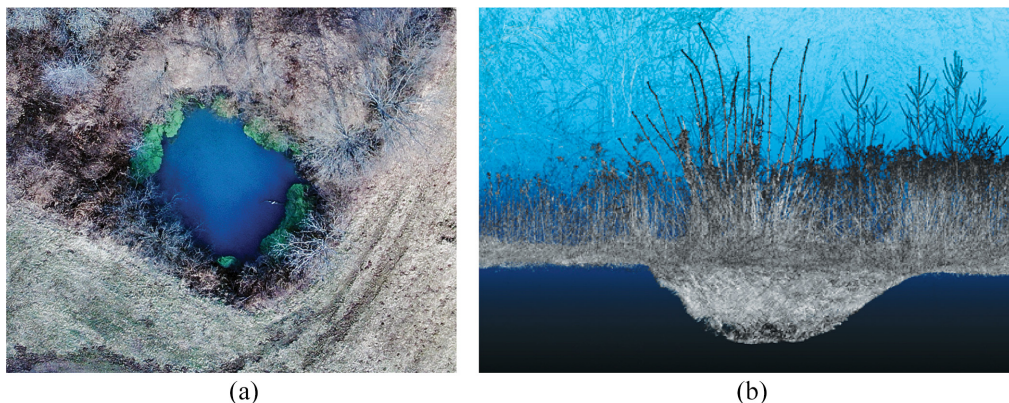
Figure 5. Examples of historical cover-collapse sinkholes, for location, see Figure 2. (a) Top view photogrammetry of sinkhole S069 (19.9 m in diameter), filled with fresh water, and (b) lidar scan of 1.5 m deep dry sinkhole S087 (5.0 m in diameter) with bushes growing out of it and filled with trash.

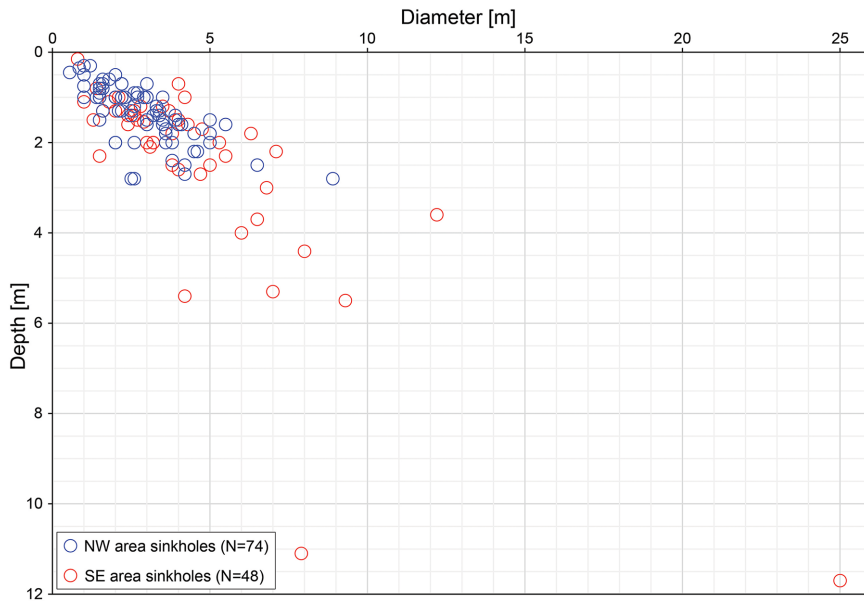
Figure 6. The largest diameter and depth of new cover-collapse sinkholes opened after 29 December 2020, Petrinja earthquake in the NW area around Borojevići (blue circles) and SE area around Mečenčani (red circles), for location, see Figure 2.

In the SE part of the studied area (Figure 2) among 48 new sinkholes most of largest and deepest opened (red symbols in Figure 6), including the largest S001 (Figure 7), S048 and S049 (Figure 8). Their collapses occurred at different times, and most sinkholes opened in predominantly clayey soil, with lenses of clayey gravel, except for S015 that is mostly in gravel. The largest sinkhole, S001, is characterized by steep walls in brown clay, with sparse 30–60 cm thick lenses of gravel. The sinkhole is nearly circular, with a depth of 11.7 m and diameter of 24.5 m as measured in March 2021 (diameter increased slightly to 25 m by December 2021). Landowners noticed the first subtle subsidence of the area on the afternoon of 4 January, which was a week after the main earthquake of 29 December 2021 (M_W 6.4). S001 collapsed between the afternoon of 4 January 2021, and 1:00 PM local time on 5 January, a week after the main M_W 6.4 earthquake of 29 December 2020

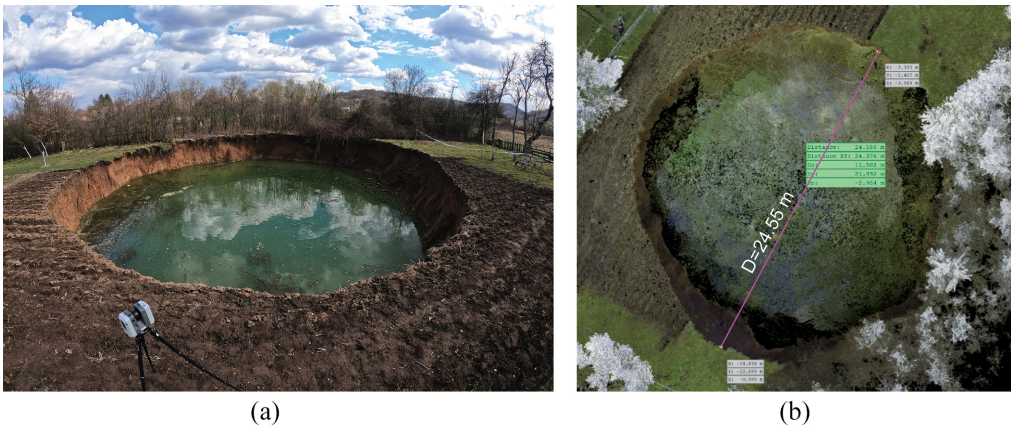
Figure 7. The largest sinkhole S001 in Mečenčani village, for location see Figure 2, (a) photograph by Ivica Pavičić and (b) lidar scan.

and more than 24 hours before the strongest M_w 4.9 aftershock that took place at 6:01 PM local time on 6 January. When it was first observed, the sinkhole was about 3 m in diameter and then gradually widened to 15 m in diameter 24 hours later due to failed walls, which remained subvertical. Figure 8 shows 2 other relatively large sinkholes (S048 and S049), in Mečenčani with a diameter of about 7 to 8 m each. S048 walls are not vertical as measured above the water level, unlike most sinkholes in the area. Its walls overhang and indicate an inclined tubular collapse of the cover with a nearly constant diameter.

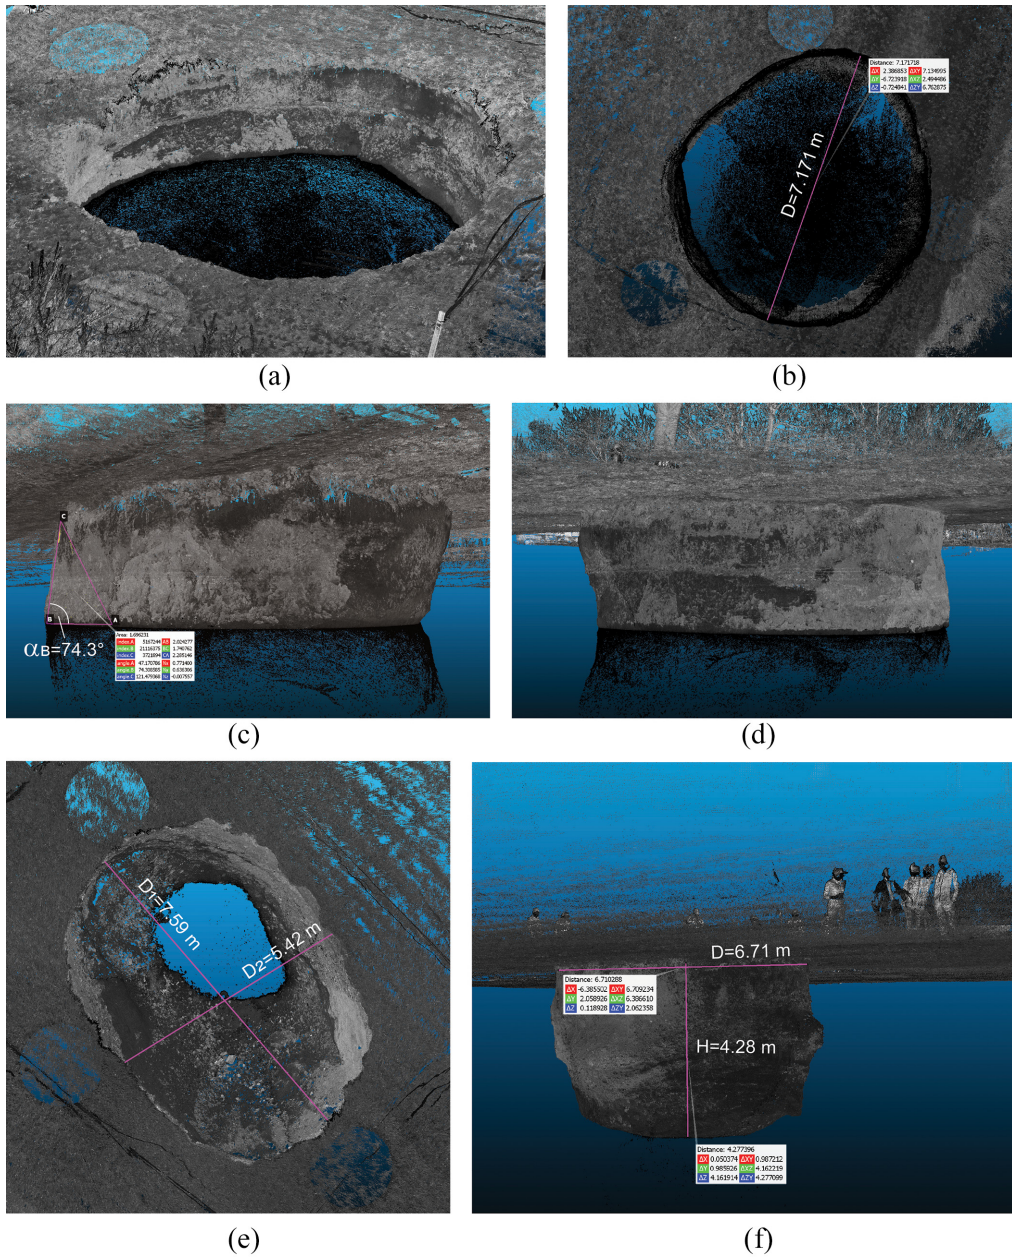
Figure 8. Examples of point cloud imagery of large sinkholes S048 ((a) to (d); 7.2 m in diameter) and S049 ((e) and (f); 7.6 m in diameter in March 2021, 8 m in December 2021; 4.28 m to water, total depth 5.6 m) in SE part of the study area in Mečenčani village, for location, see Figure 2.

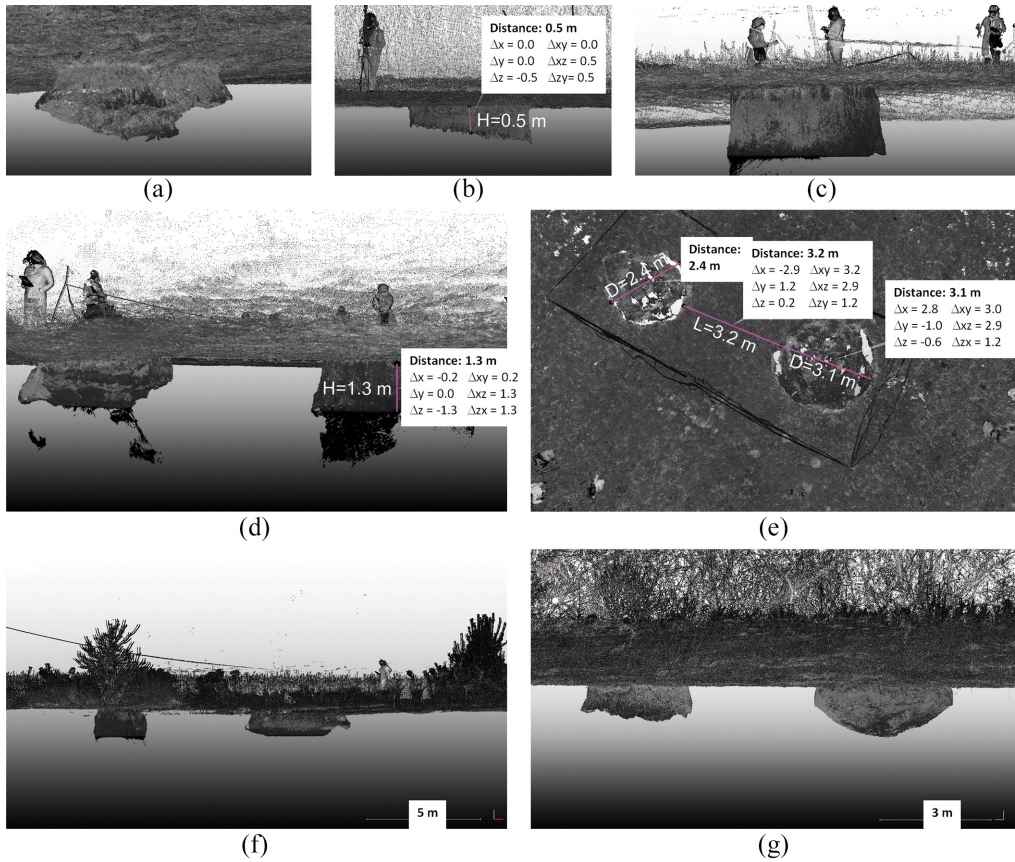
Figure 9. Examples of point cloud imagery of smaller sinkholes in NW part of the study area, NE of Borojevići village (for location, see Figure 2): (a) S012 (2.2 m in diameter), (b) S013 (2.6 m in diameter), (c) S025 (3.8 m in diameter), (d) S003 (left, largest diameter 2.9 m) and S002 (right, 3.1 m in diameter), (e) S023 (2.4 m in diameter) and S024 (3.1 m in diameter), (f) S029 (left, 2.2 m in diameter) and S028 (right, 3.9 m in diameter), and (g) S083 (left, 2.7 in diameter) and S084 (right, 3.9 m in diameter).

Smaller sinkholes, like the ones illustrated in Figure 9, dry or filled with standing water, are most common among 74 new cover-collapse sinkholes located in the NW part of the study area (Figure 2; blue symbols in Figure 6). Diameters of sinkholes in the NW part of the area vary between 0.55 m to 8.9 m, with depths between 0.3 m and 2.8 m. Figure 9

shows point cloud imagery of smaller sinkholes positioned more closely to each other than larger sinkholes from the first group. Sinkholes S012 and S013 have similar small diameters and are filled with collapsed soil and no water. While walls of S013 are nearly vertical through uniform clay, the walls of S012 show significant overhang in clayey gravel. S025 is another example of a smaller, nearly cylindrical sinkhole in clayey and fine-grained soil filled with water. Examples of double sinkholes, collapsed in close proximity, are shown in Figure 8 for the S023 and S024, S028 and S029, as well as S083 and S084 pairs.

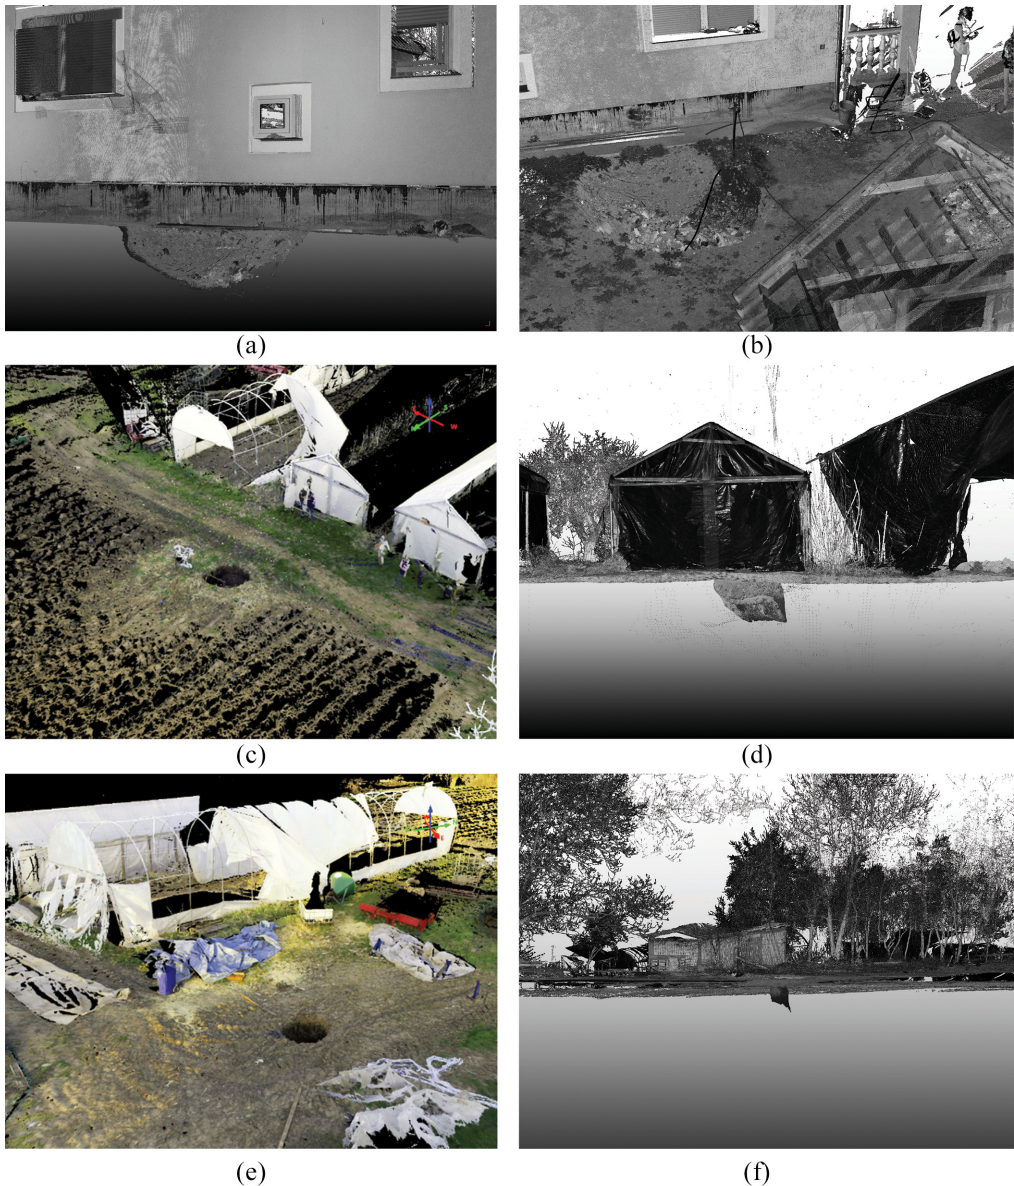
Figure 11. Lidar images of sinkholes S053 ((a) and (b), 3.2 m in diameter), S054 ((c) and (d), 2.0 m in diameter), and S055 ((e) and (f), 1.5 m in diameter) on Mečenčani family farmland (for location, see Figure 2).

Furthermore, 3 sinkholes collapsed in a nearby family farm in Mečenčani (Figure 11), S053, S054, and S055 (S054 and S055 are circular sinkholes with a small diameter, quite deep and have vertical walls).

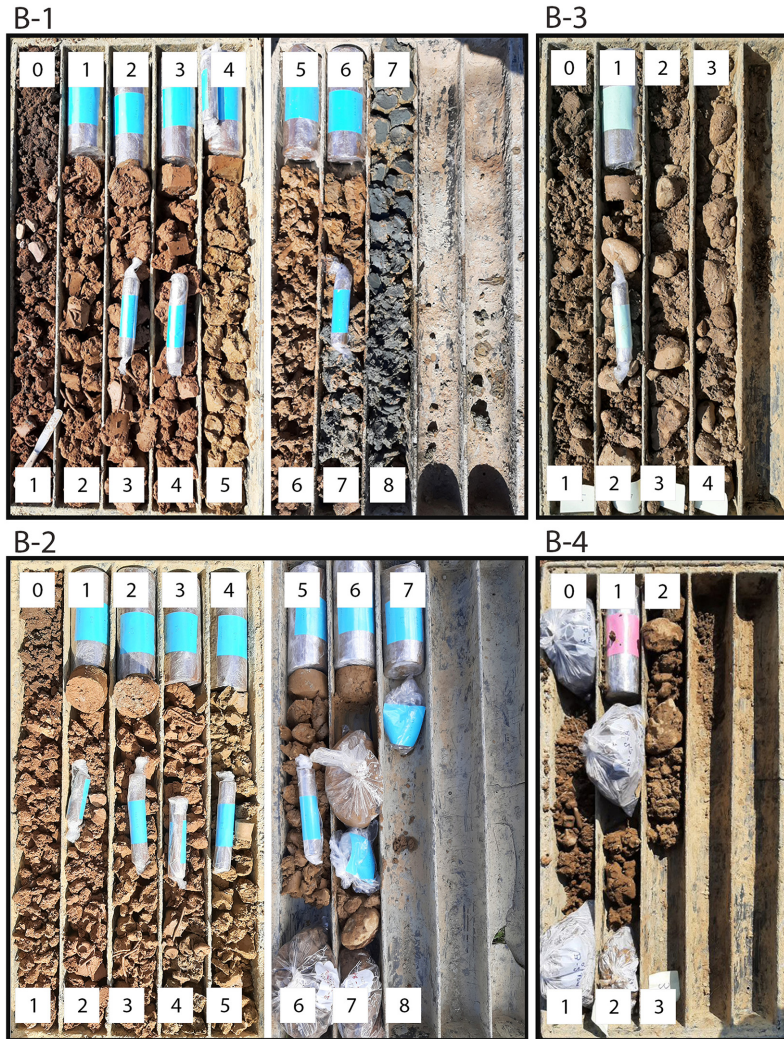
Figure 12. Soil core and sampling locations from boreholes B-1 to B-4 (photo by Evelina Oršulić). Numbers indicate depth in meters.

a depth of 8.0 and 7.6 m, respectively. Below these depths, further advancement was no longer possible either because of the presence of very stiff marly clay or the increased content of gravel-size particles (Figure 12). Boreholes B-3 and B-4 were drilled close to the sinkholes S009 and S040 in the NW part of the study area, closer to Sunja river. Drilling ended at depths of only 4.0 and 2.5 m, respectively. Below these depths, further advancement was no longer possible as the content of gravel-size particles increased (Figure 12).

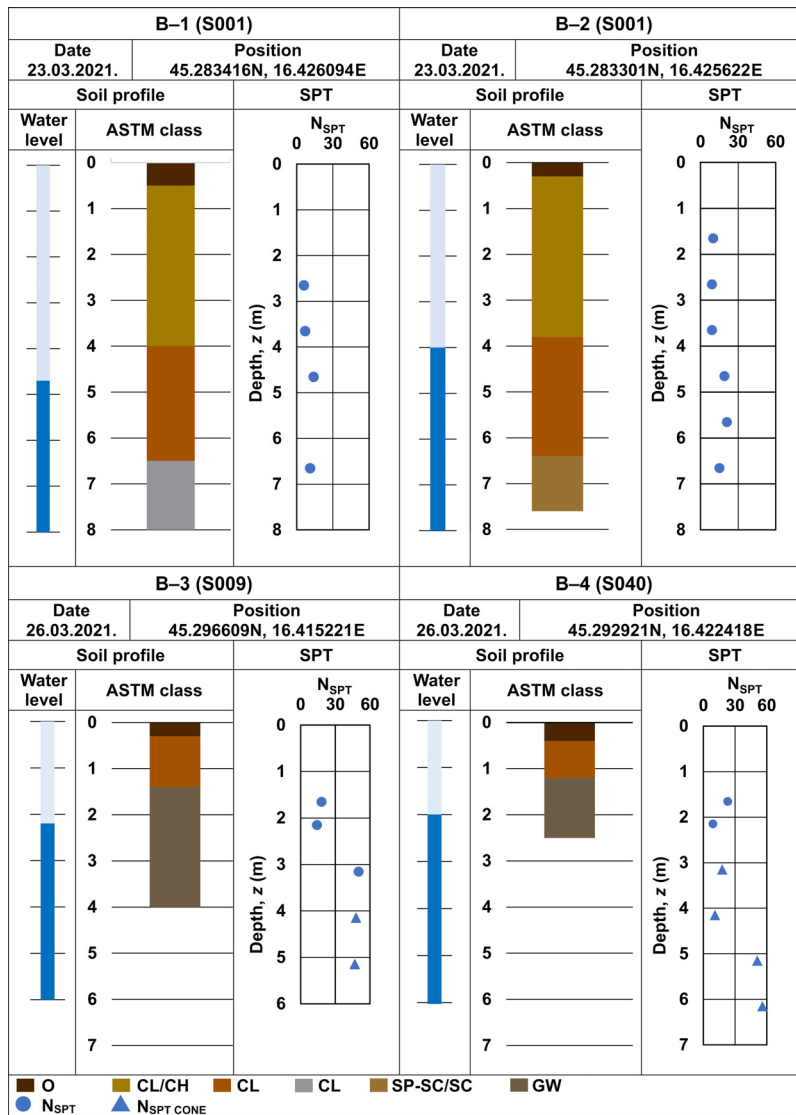
Figure 13. Boring logs for boreholes B-1 through B-4.

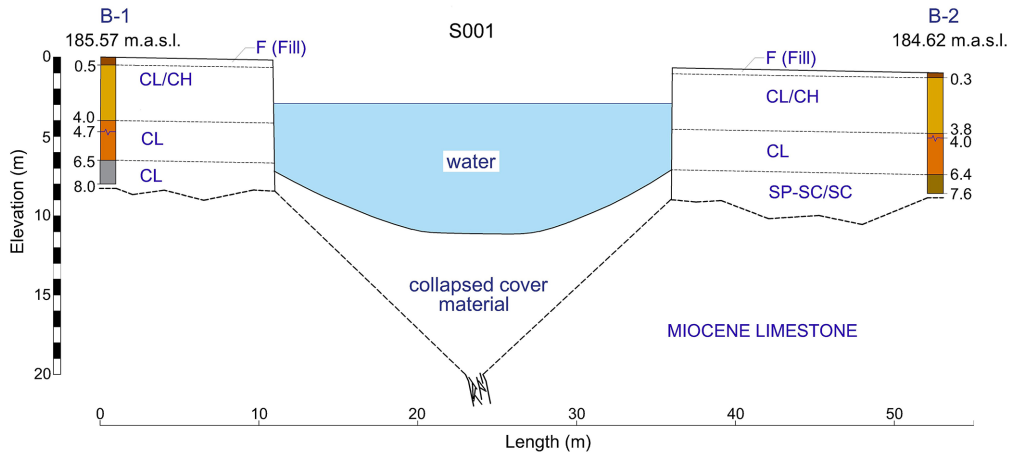
Figure 14. Vertical cross-section through sinkhole S001 and boreholes B-1 and B-2.

Based on the field description and identification, and laboratory test results, soil samples were classified according to visual and manual procedures (ASTM D2488-17, 2017) and the Unified Soil Classification System (USCS) (ASTM D2487-17, 2017). Figure 13 shows boring logs for boreholes B-1 through B-4, while a cross-section through sinkhole S001 is depicted in Figure 14.

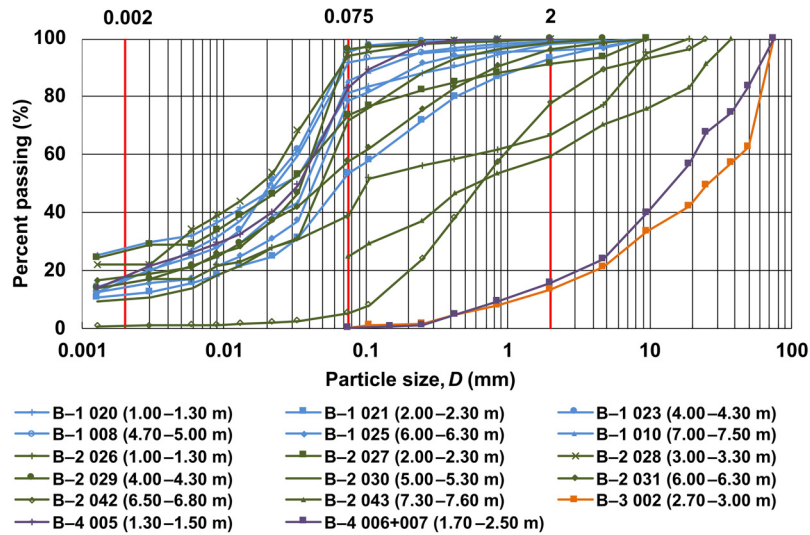
Figure 16. Grain size distribution curves for soils collected from boreholes B-1 to B-4.

Figure 15 depicts variation of Atterberg limits and natural water contents versus depth, while Figure 16 shows grain size distribution curves for soils collected from boreholes B-1 to B-4.

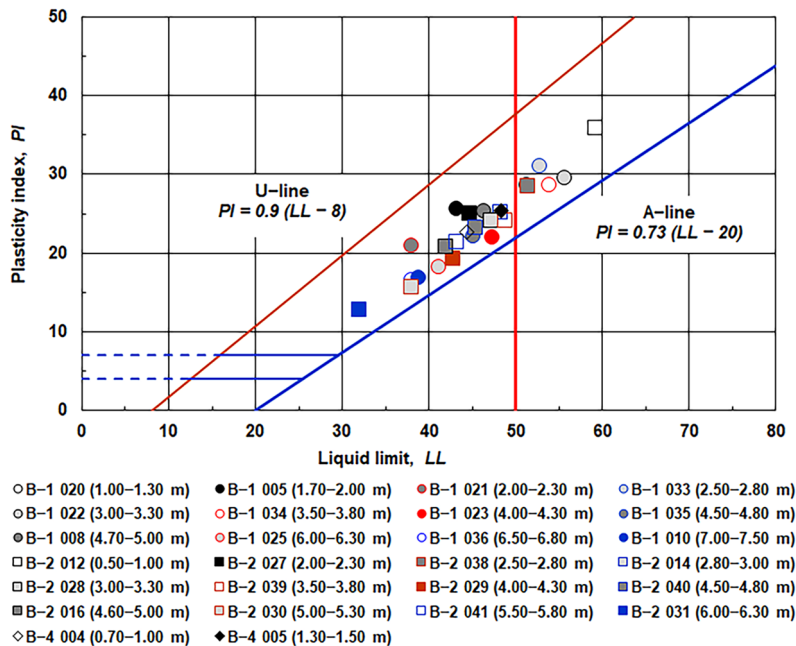
Figure 17. Casagrande plasticity chart for soils collected from boreholes B-1 (circles), B-2 (squares), and B-4 (diamonds).

Furthermore, plasticity indices and liquid limits for various soil samples collected from boreholes B-1, B-2, B-3, and B-4 are depicted in the Casagrande plasticity chart shown in Figure 17, thus indicating that most of the soil samples are in the area of low-plasticity clays with few exceptions that fall into the range of high-plasticity clays.

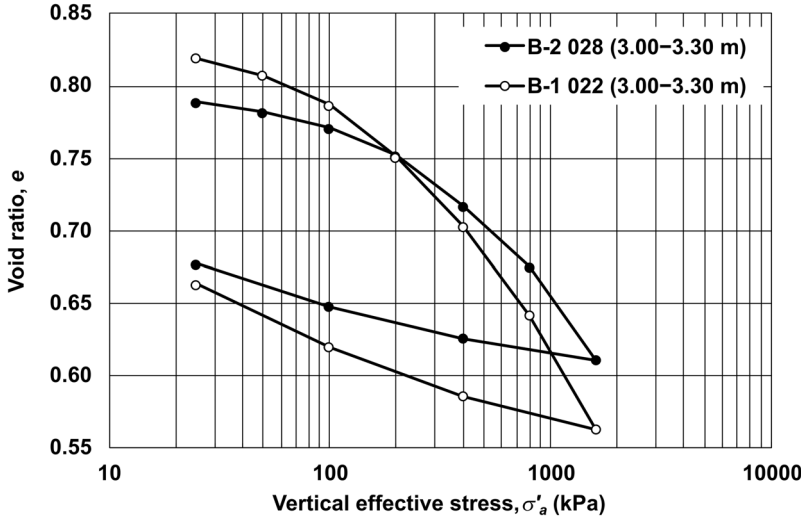
Figure 18. Results of oedometer tests performed on sample nos 022 and 028 that were collected from depths ranging between 3.0 and 3.3 m (boreholes B-1 and B-2).

Oedometer tests were performed on saturated samples. Figure 18 shows the results obtained from the sample nos 022 (B-1) and 028 (B-2). The tests were performed in

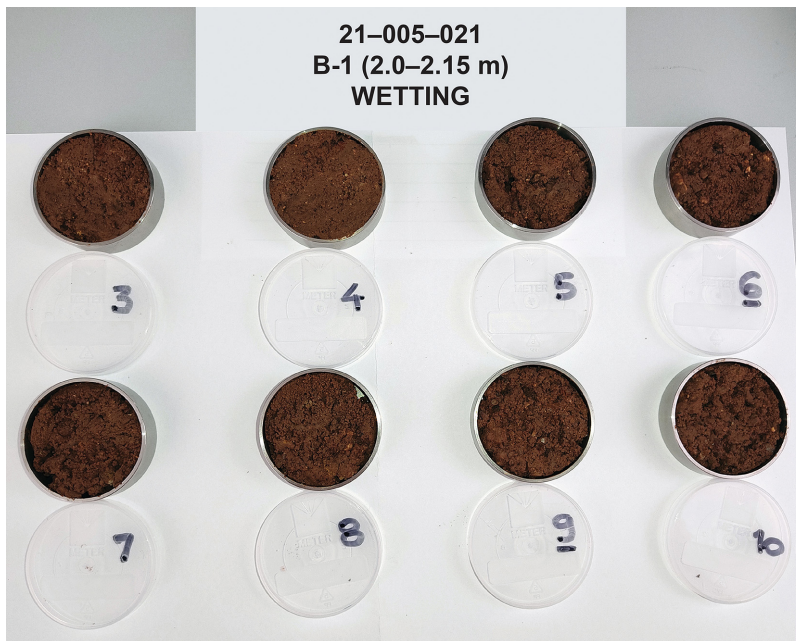
Figure 22. Specimens prepared for measurement of SWRC in a WP4C device: wetting branch of the SWRC, multiple-specimen method.

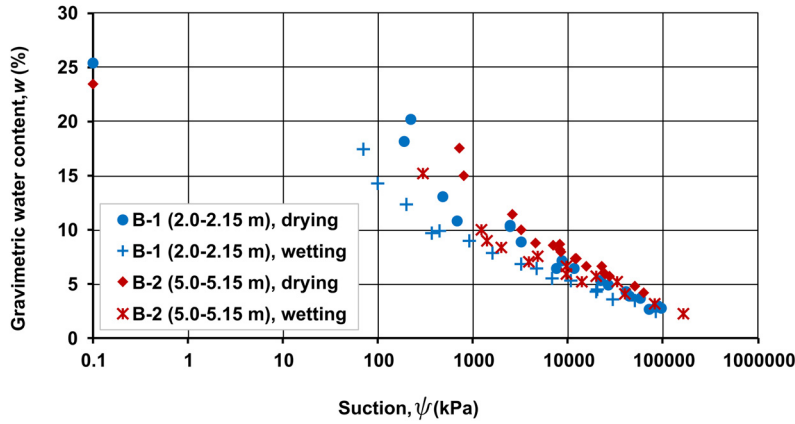
Figure 23. Results of SWRC measurements including drying and wetting paths plotted in the gravimetric water content versus the logarithm of the suction coordinate system (SWRC-w).

Results for samples no. 021 (B-1) and 030 (B-2), including drying and wetting paths, are depicted in Figures 23 and 24. In Figure 23, data are plotted in the gravimetric water

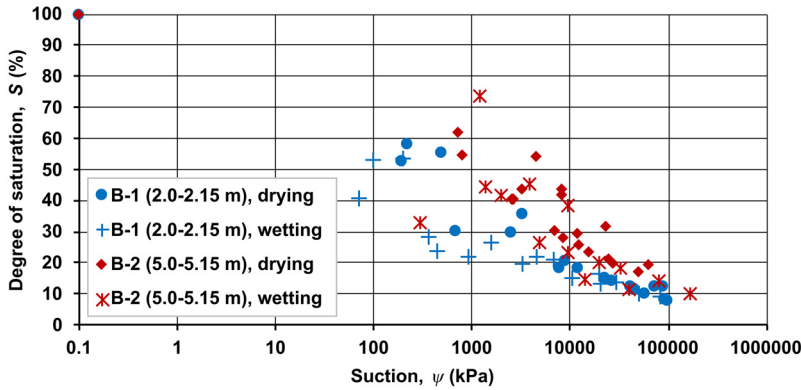
Figure 24. Results of SWRC measurements including drying and wetting paths plotted in the degree of saturation versus the logarithm of the suction coordinate system (SWRC-S).

content versus logarithm of suction coordinate system, while in Figure 24, the same data are plotted in the degree of saturation (S) versus logarithm of suction coordinate system.
