Natural building stone in the construction and renovation of the Zagreb Cathedral

Rudarsko-geološko-naftni zbornik
(The Mining-Geology-Petroleum Engineering Bulletin)
UDC: 553.5; 622; 622.3
DOI: 10.17794/rgn.2023.3.3

Review scientific paper

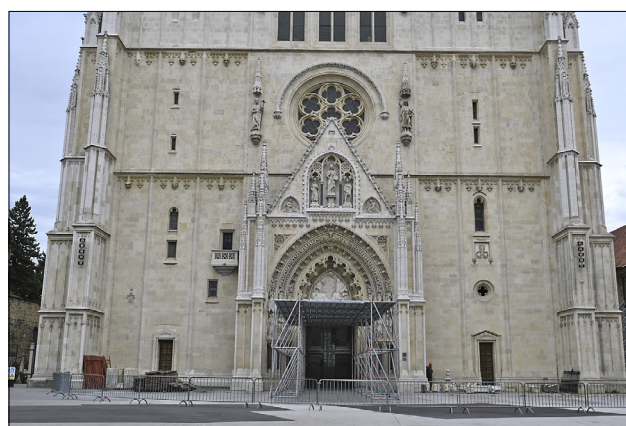
Figure 3: The restored portal of the Cathedral

During the restoration of the stone of the Zagreb Cathedral, **Crnković (1994)** emphasized the importance of cleaning, strengthening and surface protection of damaged embedded stone (see **Figure 3**). The renovation was planned in a few steps. The first step was to determine the cause, mechanism, type, intensity, and depth of damage. The second step was cleaning, which can include mechanical, chemical, and physical removal of deposited impurities from the surface of the stone. Then as a third step follows the strengthening or consolidation of elements with reduced strength and impregnation of the stone with hardeners. The last step is surface protection with special coatings that prevent water absorption.
