Geotechnical reconnaissance of an extensive cover-collapse sinkhole phenomena of 2020-2021 Petrinja earthquake sequence (Central Croatia)

Source / Izvornik: **Earthquake Spectra, 2023, 39, 653 - 686**

Abstract

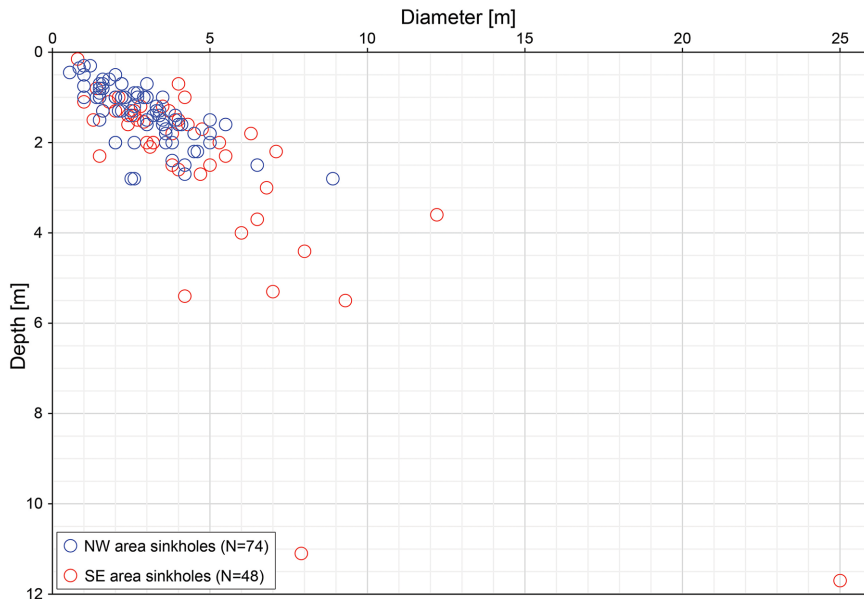
Figure 6. The largest diameter and depth of new cover-collapse sinkholes opened after 29 December 2020, Petrinja earthquake in the NW area around Borojevići (blue circles) and SE area around Mečenčani (red circles), for location, see Figure 2.

In the SE part of the studied area (Figure 2) among 48 new sinkholes most of largest and deepest opened (red symbols in Figure 6), including the largest S001 (Figure 7), S048 and S049 (Figure 8). Their collapses occurred at different times, and most sinkholes opened in predominantly clayey soil, with lenses of clayey gravel, except for S015 that is mostly in gravel. The largest sinkhole, S001, is characterized by steep walls in brown clay, with sparse 30–60 cm thick lenses of gravel. The sinkhole is nearly circular, with a depth of 11.7 m and diameter of 24.5 m as measured in March 2021 (diameter increased slightly to 25 m by December 2021). Landowners noticed the first subtle subsidence of the area on the afternoon of 4 January, which was a week after the main earthquake of 29 December 2021 (M_W 6.4). S001 collapsed between the afternoon of 4 January 2021, and 1:00 PM local time on 5 January, a week after the main M_W 6.4 earthquake of 29 December 2020

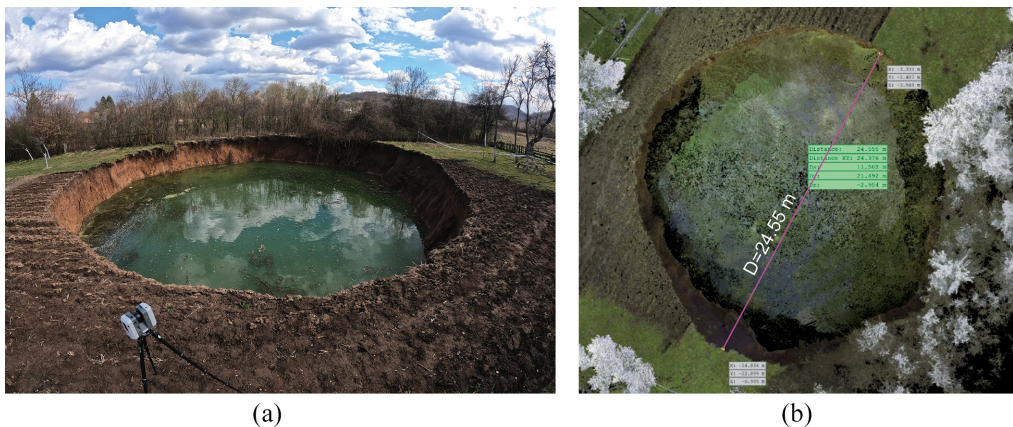
Figure 7. The largest sinkhole S001 in Mečenčani village, for location see Figure 2, (a) photograph by Ivica Pavičić and (b) lidar scan.

and more than 24 hours before the strongest M_w 4.9 aftershock that took place at 6:01 PM local time on 6 January. When it was first observed, the sinkhole was about 3 m in diameter and then gradually widened to 15 m in diameter 24 hours later due to failed walls, which remained subvertical. Figure 8 shows 2 other relatively large sinkholes (S048 and S049), in Mečenčani with a diameter of about 7 to 8 m each. S048 walls are not vertical as measured above the water level, unlike most sinkholes in the area. Its walls overhang and indicate an inclined tubular collapse of the cover with a nearly constant diameter.

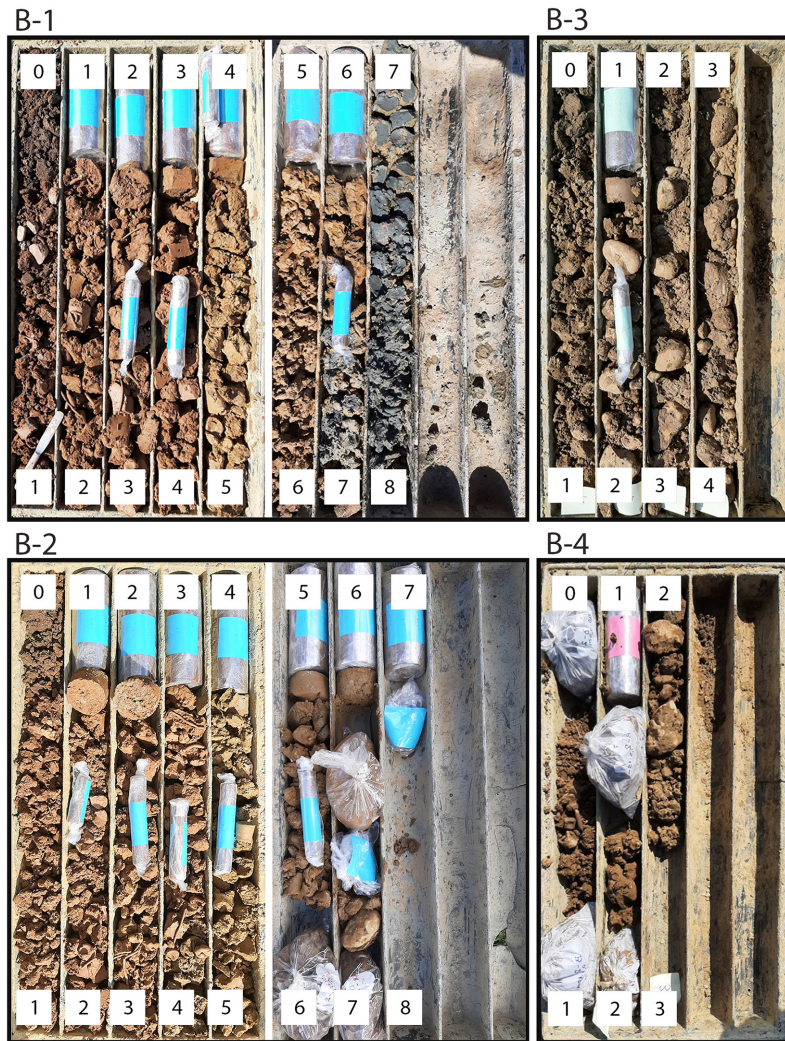
Figure 12. Soil core and sampling locations from boreholes B-1 to B-4 (photo by Evelina Oršulić). Numbers indicate depth in meters.

a depth of 8.0 and 7.6 m, respectively. Below these depths, further advancement was no longer possible either because of the presence of very stiff marly clay or the increased content of gravel-size particles (Figure 12). Boreholes B-3 and B-4 were drilled close to the sinkholes S009 and S040 in the NW part of the study area, closer to Sunja river. Drilling ended at depths of only 4.0 and 2.5 m, respectively. Below these depths, further advancement was no longer possible as the content of gravel-size particles increased (Figure 12).

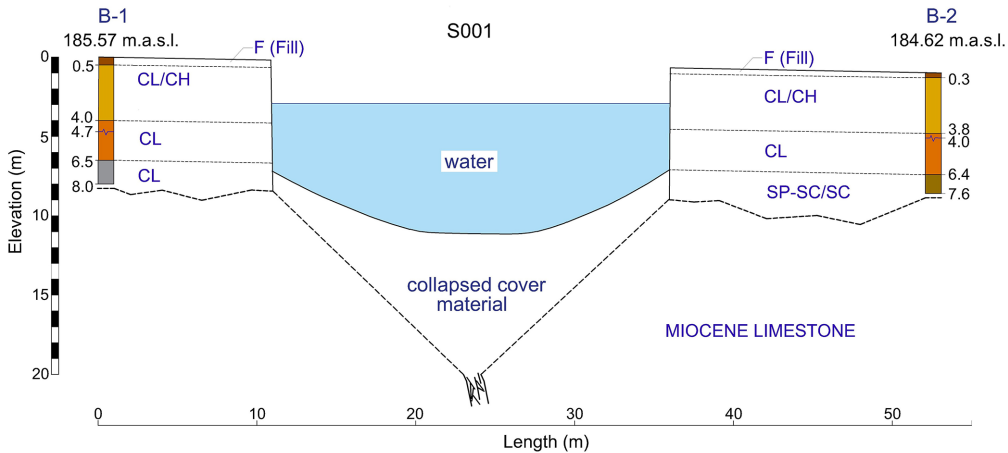
Figure 14. Vertical cross-section through sinkhole S001 and boreholes B-1 and B-2.

Based on the field description and identification, and laboratory test results, soil samples were classified according to visual and manual procedures (ASTM D2488-17, 2017) and the Unified Soil Classification System (USCS) (ASTM D2487-17, 2017). Figure 13 shows boring logs for boreholes B-1 through B-4, while a cross-section through sinkhole S001 is depicted in Figure 14.

Soil profiles of boreholes B-1 and B-2 (Figure 13) indicate that approximately top 0.5 m consists of fill with organic content (denoted by O), followed by approximately 3.5 m of sandy lean and fat clay that is firm to stiff and contains sparse traces of limestone particles with sharp edges up to 20 mm in diameter in borehole B-1 and up to 50 mm in diameter in borehole B-2, and is classified as CL/CH. The third layer consists of stiff to very stiff lean clay and lean clay with sand that is classified as CL. At the bottom of boreholes, either gray lean (marly) clay (CL in borehole B-1) or a very moist clayey sand with gravel (SP-SC/SC in borehole B-2) was found (Figures 13 and 14).

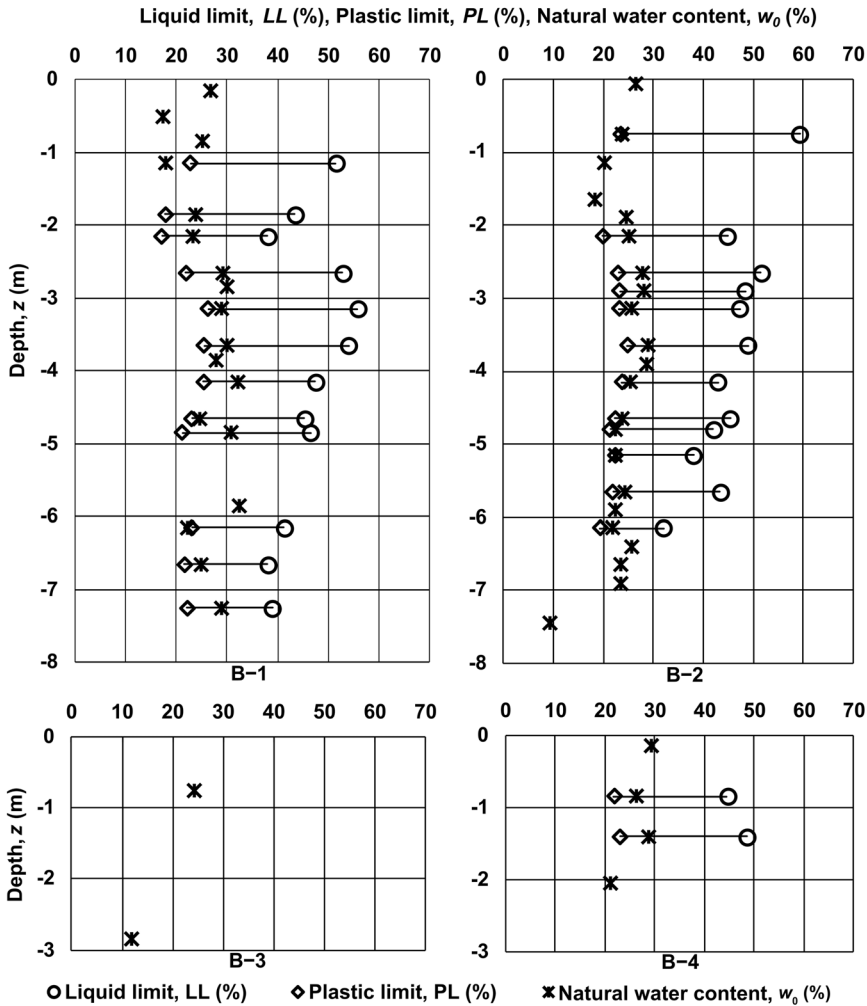
Figure 15. Atterberg limits and natural water content versus depth for boreholes B-1 to B-4.

Figure 15 depicts variation of Atterberg limits and natural water contents versus depth, while Figure 16 shows grain size distribution curves for soils collected from boreholes B-1 to B-4.

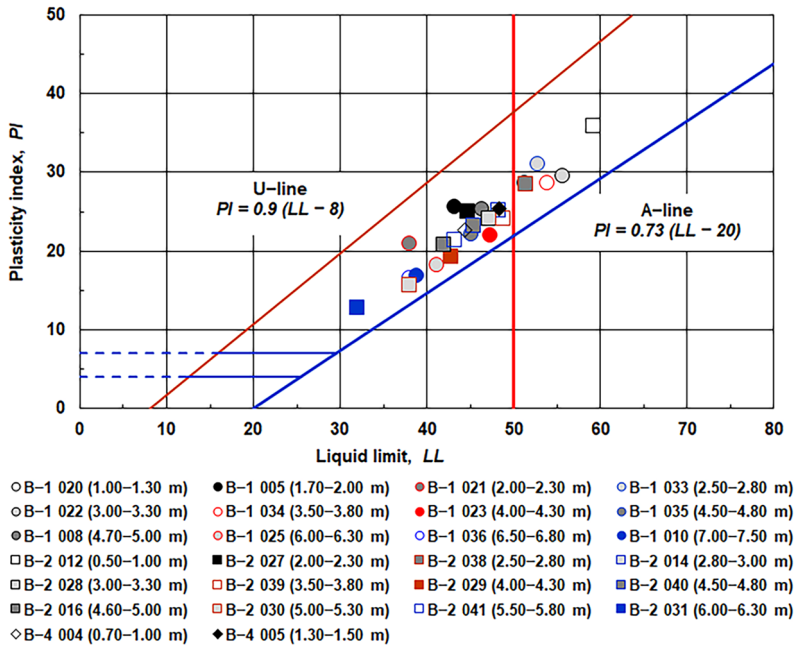
Figure 17. Casagrande plasticity chart for soils collected from boreholes B-1 (circles), B-2 (squares), and B4 (diamonds).

Furthermore, plasticity indices and liquid limits for various soil samples collected from boreholes B-1, B-2, B-3, and B-4 are depicted in the Casagrande plasticity chart shown in Figure 17, thus indicating that most of the soil samples are in the area of low-plasticity clays with few exceptions that fall into the range of high-plasticity clays.

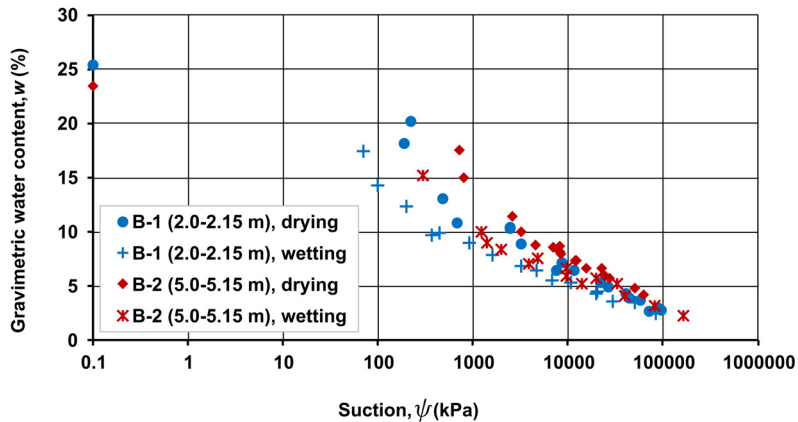
Figure 23. Results of SWRC measurements including drying and wetting paths plotted in the gravimetric water content versus the logarithm of the suction coordinate system (SWRC-w).

Results for samples no. 021 (B-1) and 030 (B-2), including drying and wetting paths, are depicted in Figures 23 and 24. In Figure 23, data are plotted in the gravimetric water

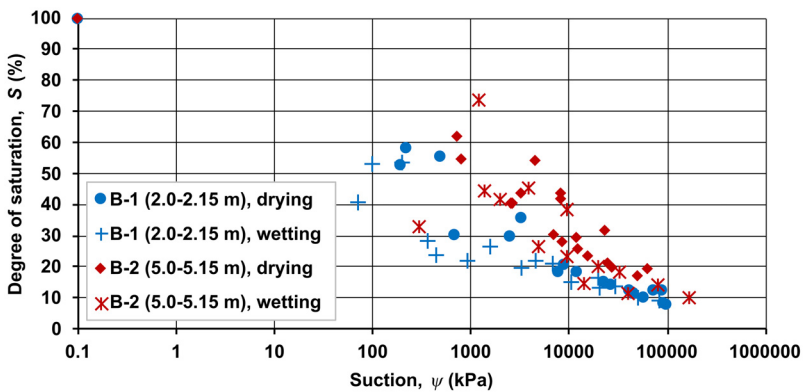
Figure 24. Results of SWRC measurements including drying and wetting paths plotted in the degree of saturation versus the logarithm of the suction coordinate system (SWRC-S).

content versus logarithm of suction coordinate system, while in Figure 24, the same data are plotted in the degree of saturation (S) versus logarithm of suction coordinate system.
