Geotechnical reconnaissance of an extensive cover-collapse sinkhole phenomena of 2020-2021 Petrinja earthquake sequence (Central Croatia)

Geotechnical reconnaissance of an extensive cover-collapse sinkhole phenomena of 2020–2021 Petrinja earthquake sequence (Central Croatia)

Earthquake Spectra

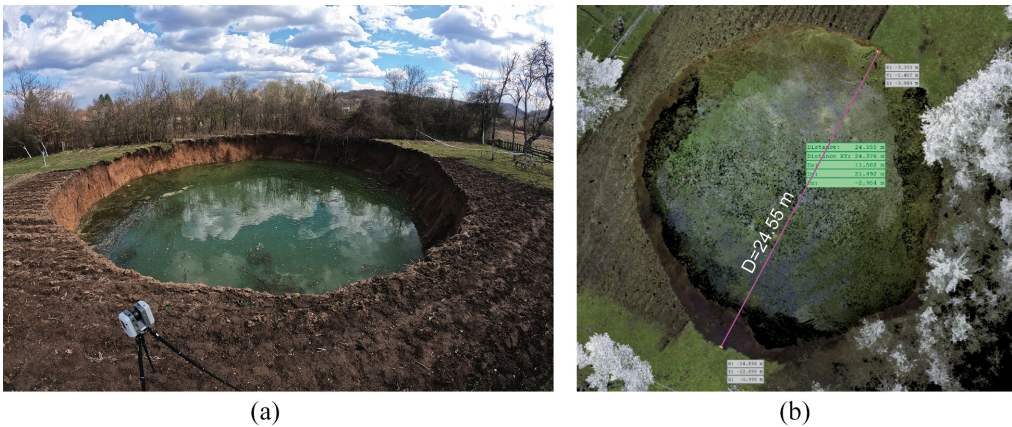
Figure 7. The largest sinkhole S001 in Mečenčani village, for location see Figure 2, (a) photograph by Ivica Pavičić and (b) lidar scan.

and more than 24 hours before the strongest M_w 4.9 aftershock that took place at 6:01 PM local time on 6 January. When it was first observed, the sinkhole was about 3 m in diameter and then gradually widened to 15 m in diameter 24 hours later due to failed walls, which remained subvertical. Figure 8 shows 2 other relatively large sinkholes (S048 and S049), in Mečenčani with a diameter of about 7 to 8 m each. S048 walls are not vertical as measured above the water level, unlike most sinkholes in the area. Its walls overhang and indicate an inclined tubular collapse of the cover with a nearly constant diameter.

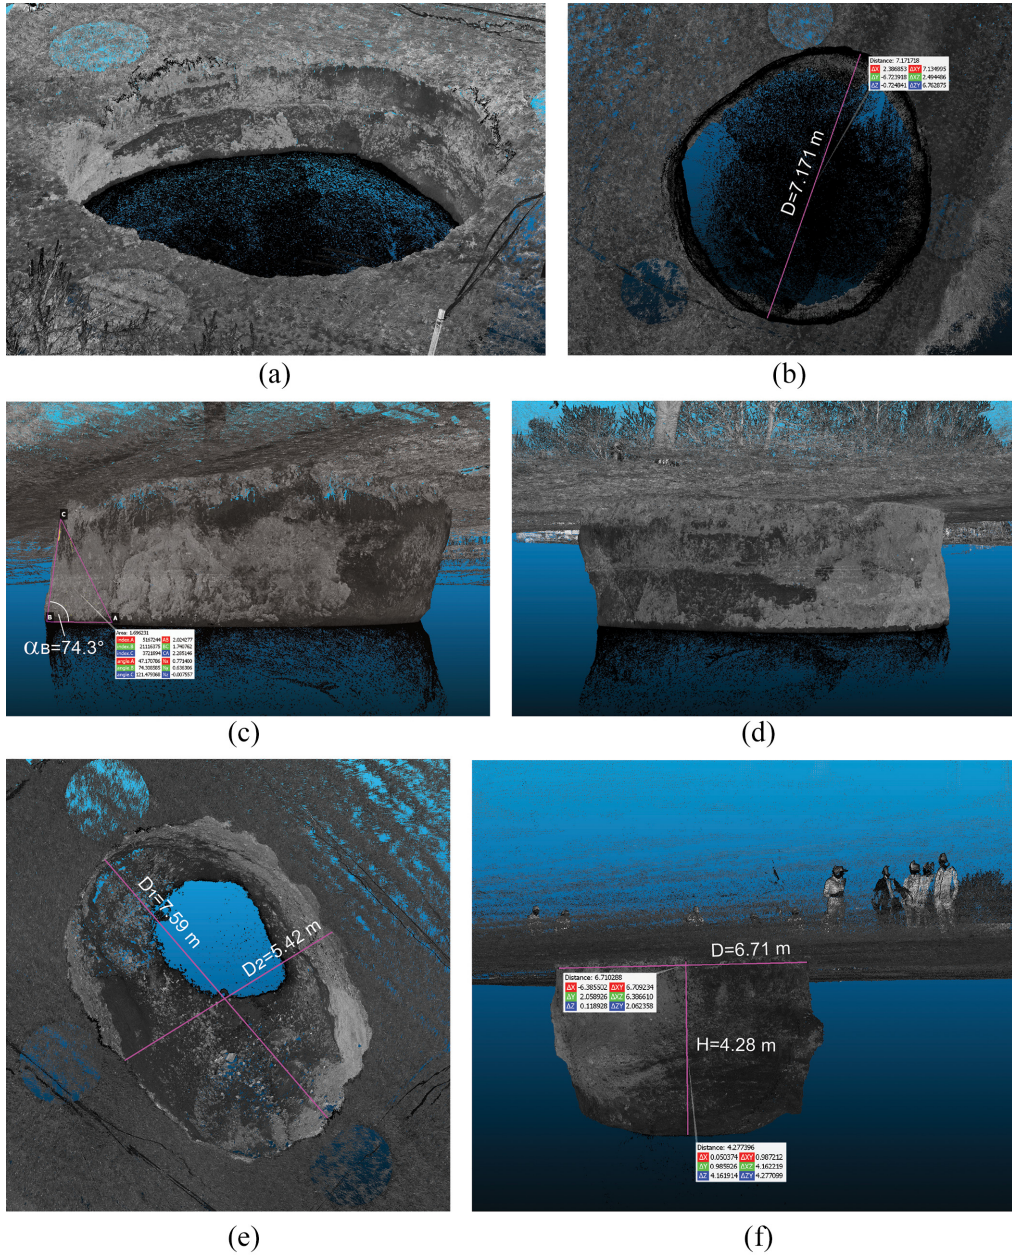
Figure 8. Examples of point cloud imagery of large sinkholes S048 ((a) to (d); 7.2 m in diameter) and S049 ((e) and (f); 7.6 m in diameter in March 2021, 8 m in December 2021; 4.28 m to water, total depth 5.6 m) in SE part of the study area in Mečenčani village, for location, see Figure 2.

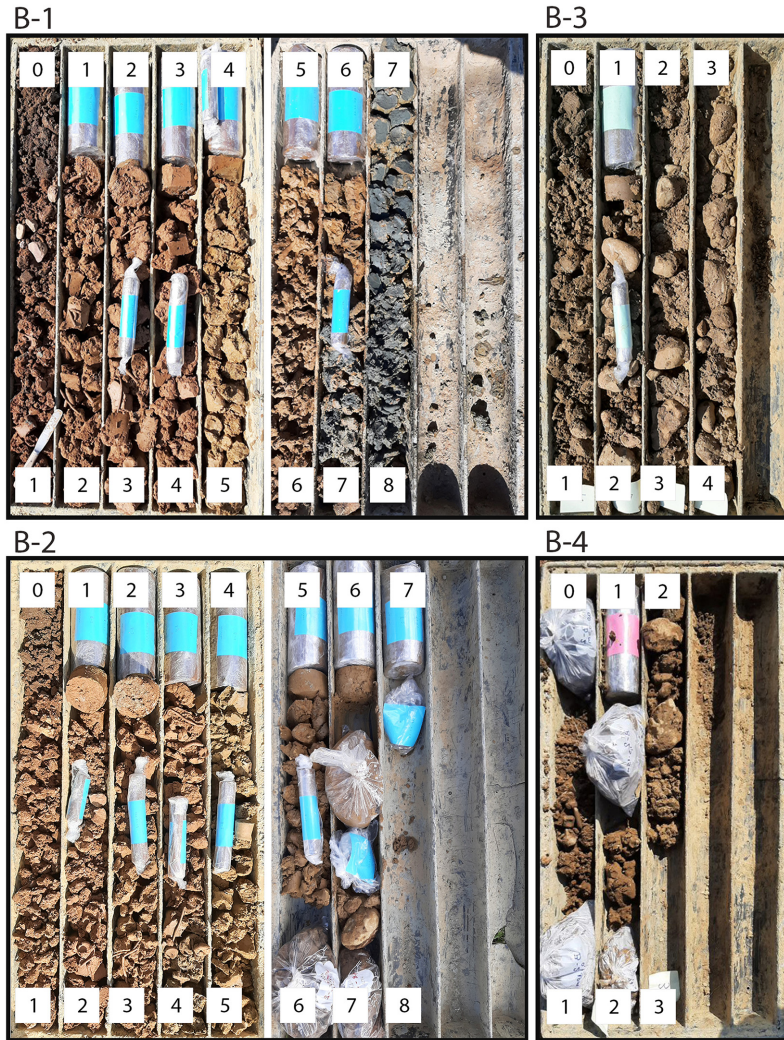
Figure 12. Soil core and sampling locations from boreholes B-1 to B-4 (photo by Evelina Oršulić). Numbers indicate depth in meters.

a depth of 8.0 and 7.6 m, respectively. Below these depths, further advancement was no longer possible either because of the presence of very stiff marly clay or the increased content of gravel-size particles (Figure 12). Boreholes B-3 and B-4 were drilled close to the sinkholes S009 and S040 in the NW part of the study area, closer to Sunja river. Drilling ended at depths of only 4.0 and 2.5 m, respectively. Below these depths, further advancement was no longer possible as the content of gravel-size particles increased (Figure 12).
