# Natural building stone in the construction and renovation of the Zagreb Cathedral

Rudarsko-geološko-naftni zbornik  
(The Mining-Geology-Petroleum Engineering Bulletin)  
UDC: 553.5; 622; 622.3  
DOI: 10.17794/rgn.2023.3.3

Review scientific paper

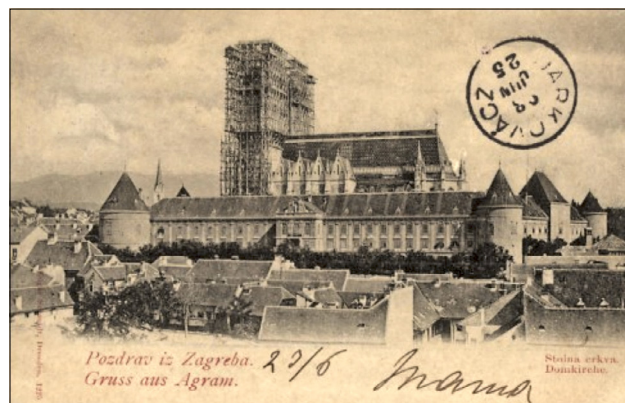
**Figure 2:** The Cathedral from the period of Bolle's extension in 1898 (Digitalna.NSK.HR, 2019)

Since the strong earthquake in 1880, the Cathedral has been rebuilt several times. During its first renovation (see Figure 2), which was carried out by the plans of the Austrian architect Friedrich von Schmidt (Nadilo, 2005), and under the direction of the Croatian architect of German origin Hermann Bollé, autochthonous stone was used, including lithothamnium limestone, litavac and carbonate sandstone. During the second renovation in 1930/1931, which lasted until World War II, a total of 747 pieces of stone carvings were replaced on the southern bell tower (Foretić, 2019). In the renovation during 1967/1968 the top of the northern tower was restored, in which the stone variety from Bizek was used. Renovations which lasted until the earthquakes in 2020 began in 1987. During this most recent renovation, lithothamnium limestone and litavac from Bizek were replaced with travertine, chosen by the Committee for the Restoration of the Cathedral upon the recommendation of Professor Branko Crnković (Foretić, 2019).

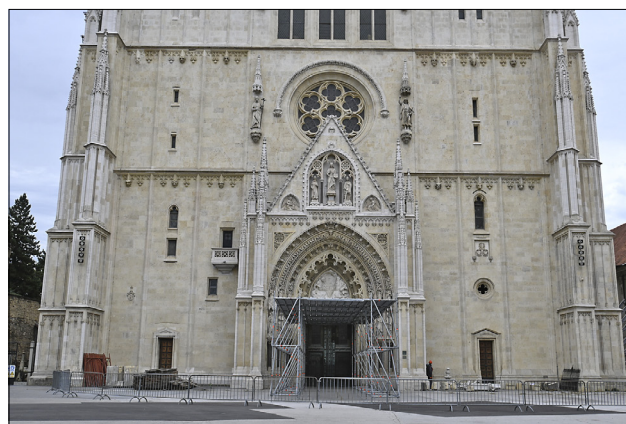
**Figure 3:** The restored portal of the Cathedral

During the restoration of the stone of the Zagreb Cathedral, **Crnković (1994)** emphasized the importance of cleaning, strengthening and surface protection of damaged embedded stone (see **Figure 3**). The renovation was planned in a few steps. The first step was to determine the cause, mechanism, type, intensity, and depth of damage. The second step was cleaning, which can include mechanical, chemical, and physical removal of deposited impurities from the surface of the stone. Then as a third step follows the strengthening or consolidation of elements with reduced strength and impregnation of the stone with hardeners. The last step is surface protection with special coatings that prevent water absorption.

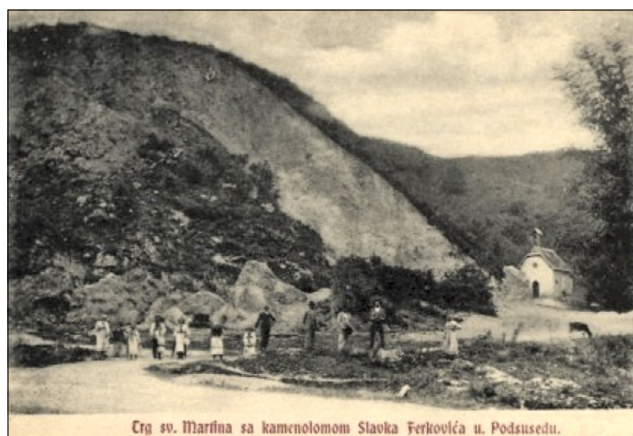
**Figure 11:** Slavko Ferković's Quarry in Podsused (**Digitalna.NSK.HR, 2019**)

Our research led to the realization that there are only few historical visual representations showing quarries and stone exploitation which are classified as public property and can be used without special copyright protection, of course with citing the source. Only one photograph (see **Figure 11**) showing Slavko Ferković's Quarry in Podsused, taken before 1905, has been found in the Digital Collection of the National and University Library in Zagreb (**Digitalna.NSK.HR, 2019**). Even though no building stone was quarried in this quarry, the photo still deserves to be shown, since it represents an important contribution to the memory of stone quarrying in the Zagreb area.
