Excessive flysch erosion - Slani Potok

Source / Izvornik: **Field trip guidebook / 3rd Mid-European Clay Conference - MECC 06, 2006, 48 - 51**

Excessive flysch erosion – Slani Potok

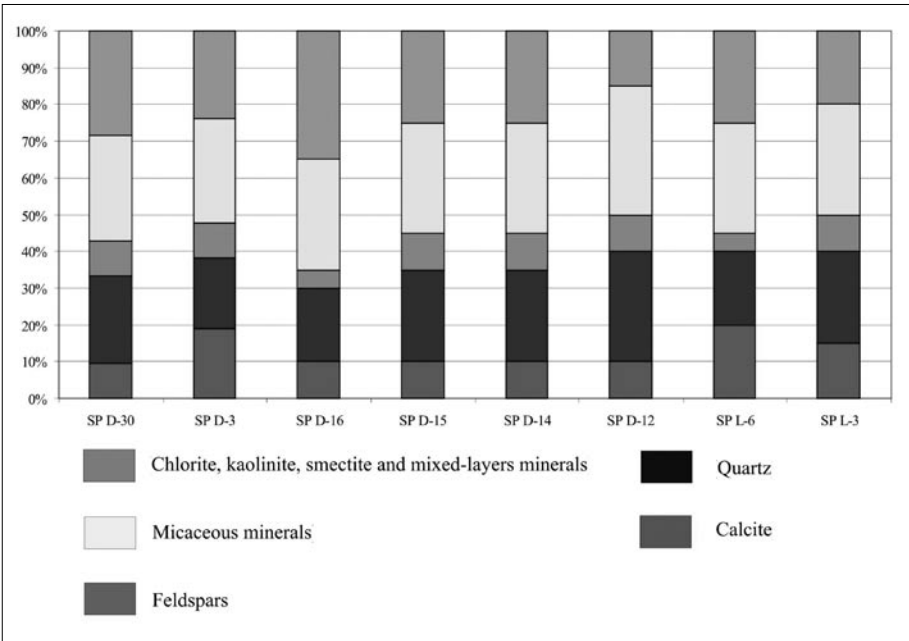
Fig. 17 Mineral content of the flysch samples (semiquantitative content).

feldspars (<10 wt.%), chlorite, kaolinite and smectite, and in some samples a small quantity of pyrite (Fig. 17). There is a large amount of small particles: the particle size fraction smaller than 2 µm and the 2–4 µm fraction form up to 45 wt.% and 15 wt.%, respectively (Fig. 18).

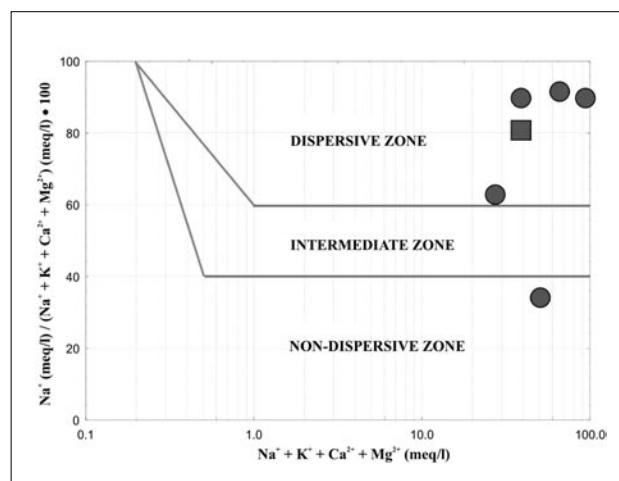
Fig. 23 Cations in the pore water of the flysch samples. Potential dispersivity chart after SHERARD et al. (1976). Stability after pinhole test: rectangle – nondispersive, circle – dispersive.

A series of physical and chemical tests were carried out in an attempt to verify this assumption. Flysch samples were submitted to physical stability tests (pinhole test and cyclic dry-wet repeat treatment – Civil Engineering Insti-

tute of Croatia, Zagreb) indicating high soil erodibility. The degree of expansiveness of engineering soils is described by Fig. 22. Determination of soluble salts in flysch pore water was carried out following a modified procedure used by the International Soil Reference and Information Centre (VAN REEUWIJK, 2002). Using criteria established by SHERARD et al. (1976), the analysed flysch fall into the group of dispersive, i.e. erodible soils (Fig. 23). Analysis of stream water for soluble salts was also carried out. Measured concentrations of Na^+ and SO_4^{2-} are much higher than the average for fresh water. This illustrated discovery of thenardite is the first occurrence of this mineral in Croatia.
