Geotechnical reconnaissance of an extensive cover-collapse sinkhole phenomena of 2020-2021 Petrinja earthquake sequence (Central Croatia)

Source / Izvornik: **Earthquake Spectra, 2023, 39, 653 - 686**

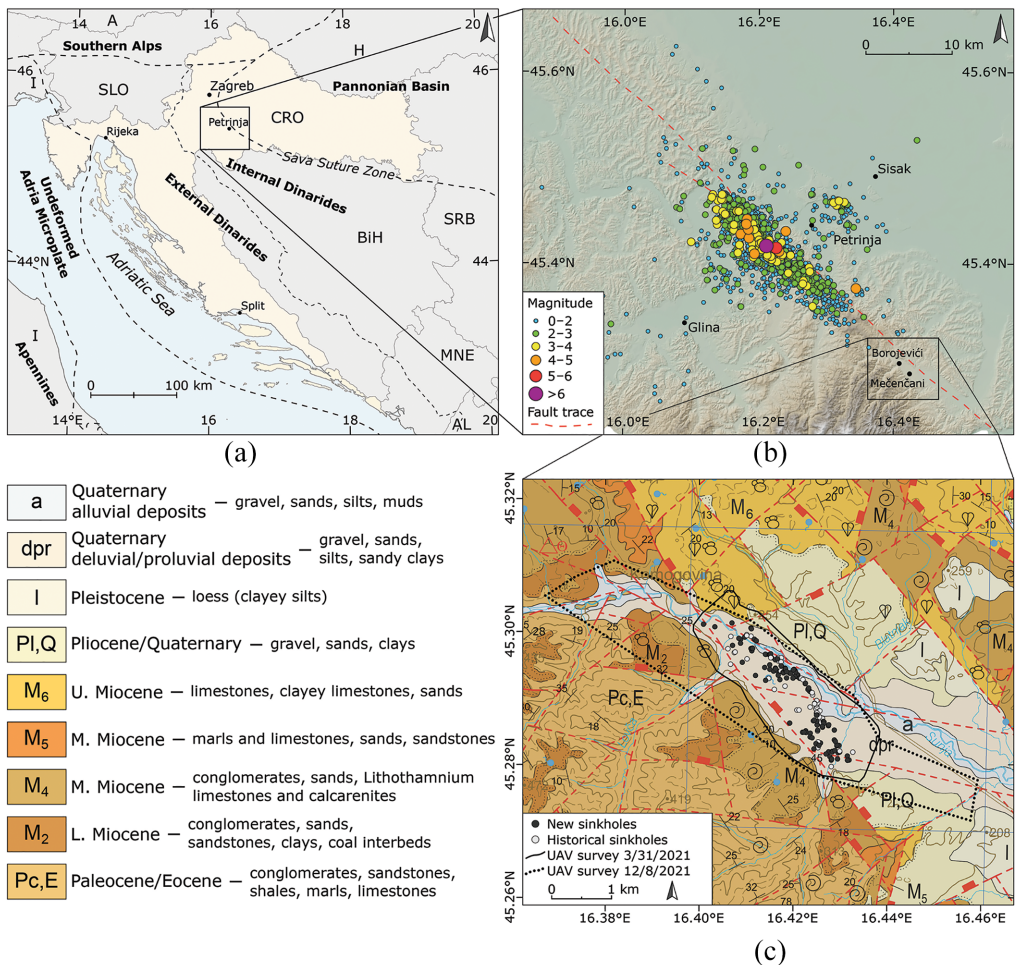
Figure 1. (a) Map of Croatia with the earthquake epicentral region; (b) epicenters of earthquakes recorded within first 2 weeks of 2020–2021 Petrinja earthquake sequence (Herak and Herak, 2021, personal communication) and the fault trace (Tomac et al., 2021); and (c) detail of geological map (Šikić, 2014) showing locations of new and historical cover-collapse sinkholes and study area covered by UAV surveys of 31 March 2021 (full black line) and 8 December 2021 (dotted black line).

The bulk of the Petrinja sequence epicenters are elongated in the NW–SE direction across roughly 20 km in length and 2–4 km in width (Figure 1b), within the Hrastovica Hill between the Kupa and Petrinjčica rivers. The main cluster is slightly asymmetric, with aftershocks protruding to the SW, especially in the central zone. A distinct NW–SE oriented sub-cluster of events in the length of about 9 km, separated from the main Hrastovica Hill cluster, is observed to the NE between Petrinja and Sisak. The mainshock

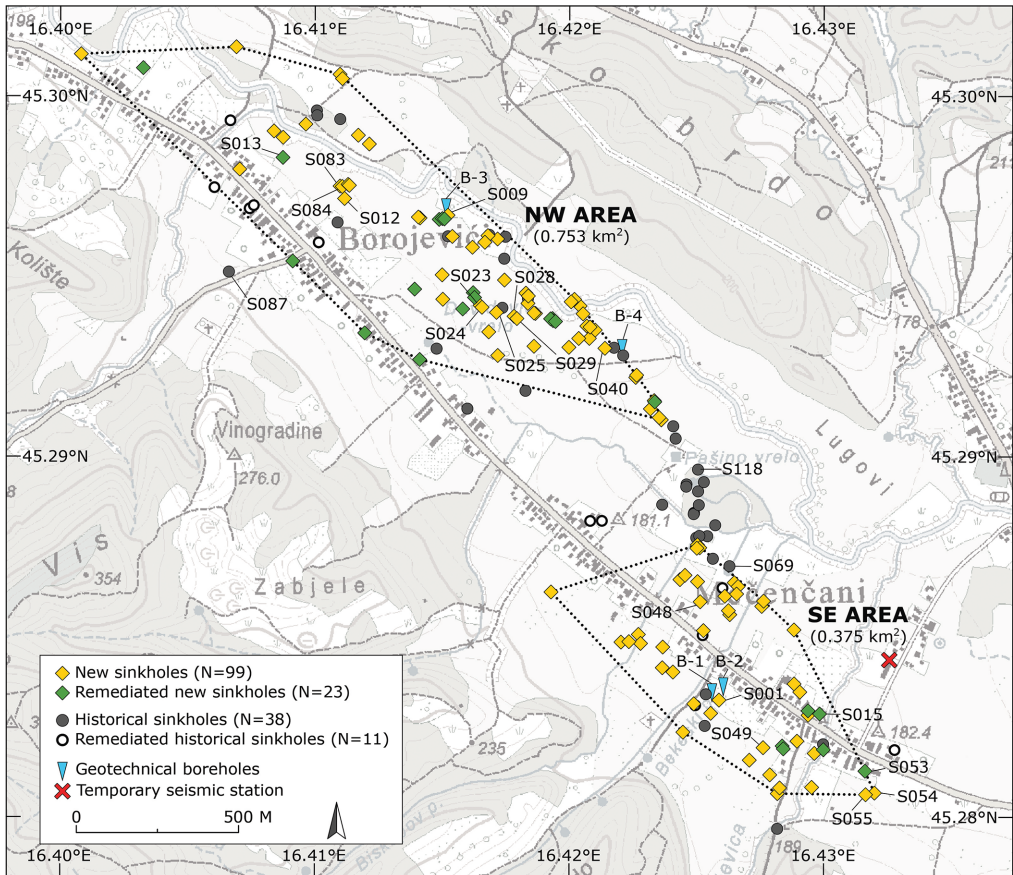
Figure 2. Plan view of new cover-collapse sinkholes (yellow diamonds), remediated new sinkholes (green diamonds), historical cover-collapse sinkholes (black circles), and remediated historical sinkholes (white circles) in the area of Mečenani and Borojevići, location of geotechnical boreholes B-1 to B-4 and temporary seismic station PN06 installed on 4 January 2021. The entire map is included within the survey area.

The GEER team identified 49 pre-existing, historical sinkholes (Tomac et al., 2021), marked in Figure 2 as circles (gray circles for not remediated and white ones for

In the SE part of the studied area (Figure 2) among 48 new sinkholes most of largest and deepest opened (red symbols in Figure 6), including the largest S001 (Figure 7), S048 and S049 (Figure 8). Their collapses occurred at different times, and most sinkholes opened in predominantly clayey soil, with lenses of clayey gravel, except for S015 that is mostly in gravel. The largest sinkhole, S001, is characterized by steep walls in brown clay, with sparse 30–60 cm thick lenses of gravel. The sinkhole is nearly circular, with a depth of 11.7 m and diameter of 24.5 m as measured in March 2021 (diameter increased slightly to 25 m by December 2021). Landowners noticed the first subtle subsidence of the area on the afternoon of 4 January, which was a week after the main earthquake of 29 December 2021 (M_W 6.4). S001 collapsed between the afternoon of 4 January 2021, and 1:00 PM local time on 5 January, a week after the main M_W 6.4 earthquake of 29 December 2020

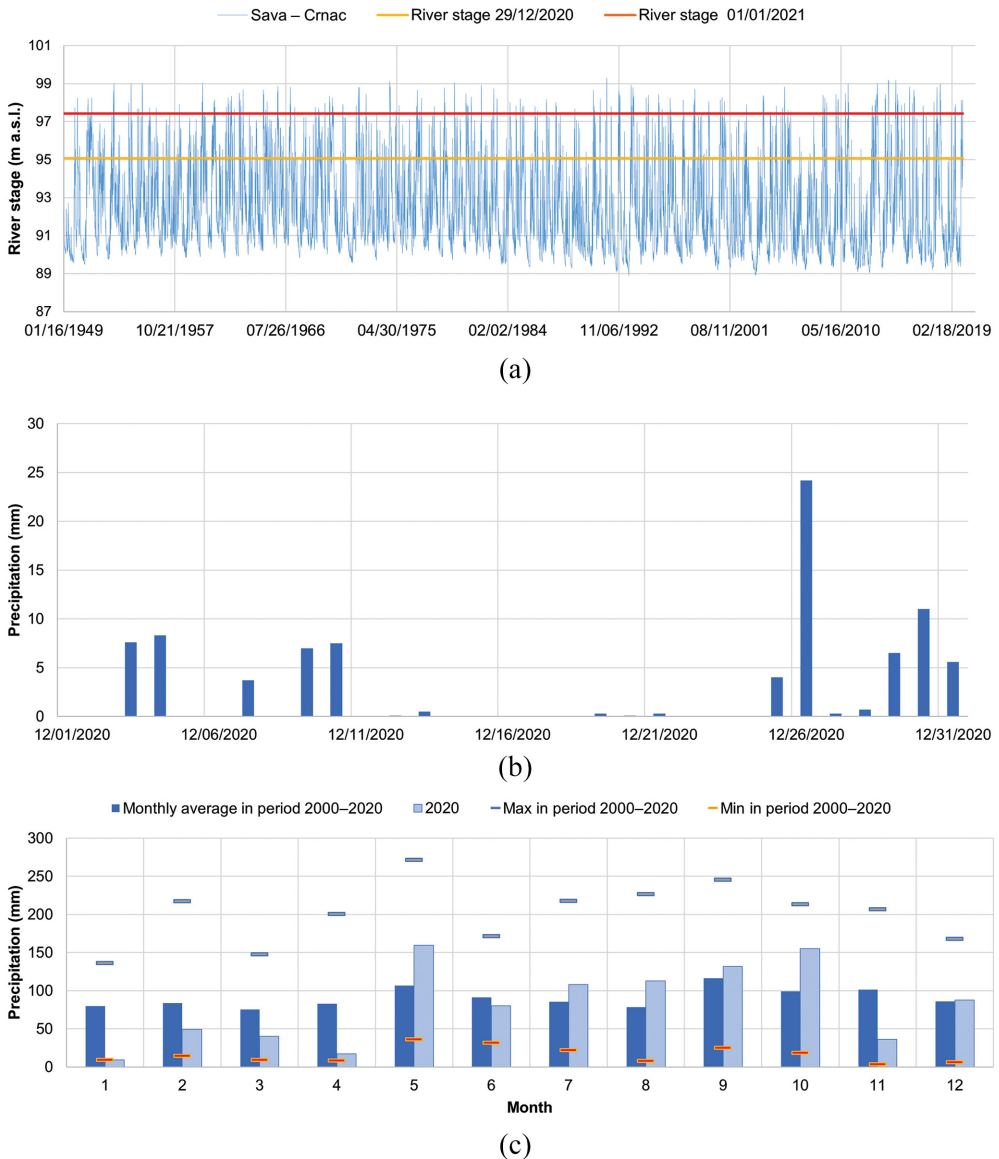
Figure 3. (a) Sava river stages during the 1949–2019 period at the gauging station in Crnac with stages on 29 December 2020 (yellow line) and 1 January 2021 (red line), (b) daily precipitation at the Mečenčani rainfall station during December 2020, and (c) average, maximum, and minimum precipitation per month in 2000–2020 period in Mečenčani.

To assess the hydrological conditions in Mečenčani and Borojevići area, the time series of stage data on the Sava River from 1949–2019 were analyzed (Figure 3a). The gauging station is located approximately 17 km to the north of the investigated area. The high values of stage in Sava River appeared due to heavy rainfall in the second half of December (Figure 3b). Analysis of the stage data on the Sava River shows that the earthquake occurred during high waters, and at a time of rapidly increasing water levels (Figure 3a), the water level in the aquitard was very close to the surface, and in the underlying karst aquifer, artesian conditions prevailed (Tomac et al., 2021). In Figure 3c, blue lines represent maximum precipitation and red lines minimum precipitation in the 2000–2020 period. However, the monthly value of precipitation in December 2020 does not deviate from the average precipitation in December recorded in the 2000–2020 period (Figure 3c).

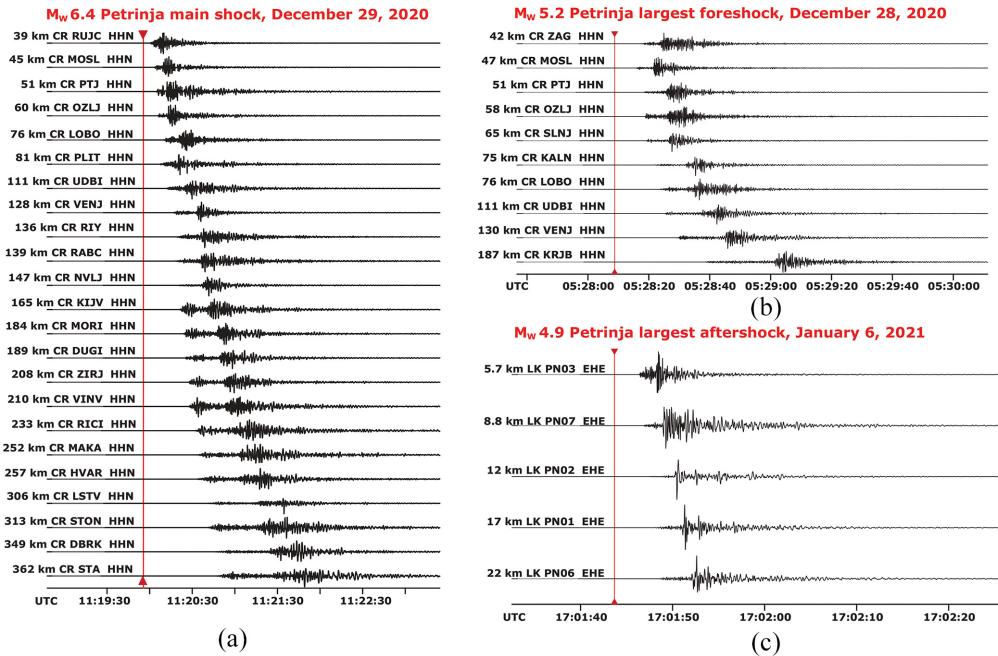
Figure 4. Petrinja earthquake seismograms showing (a) main shock and (b) largest foreshock recorded on permanent seismic stations, and (c) aftershock recorded on temporary stations installed on 5 January 2021 (temporary seismic station LK PN06 was in Mečenčani, for location, see Figure 2).

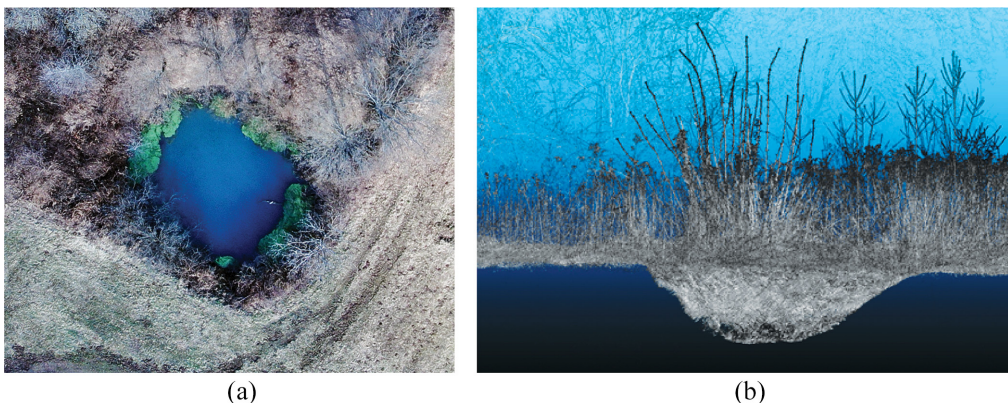
Figure 5. Examples of historical cover-collapse sinkholes, for location, see Figure 2. (a) Top view photogrammetry of sinkhole S069 (19.9 m in diameter), filled with fresh water, and (b) lidar scan of 1.5 m deep dry sinkhole S087 (5.0 m in diameter) with bushes growing out of it and filled with trash.

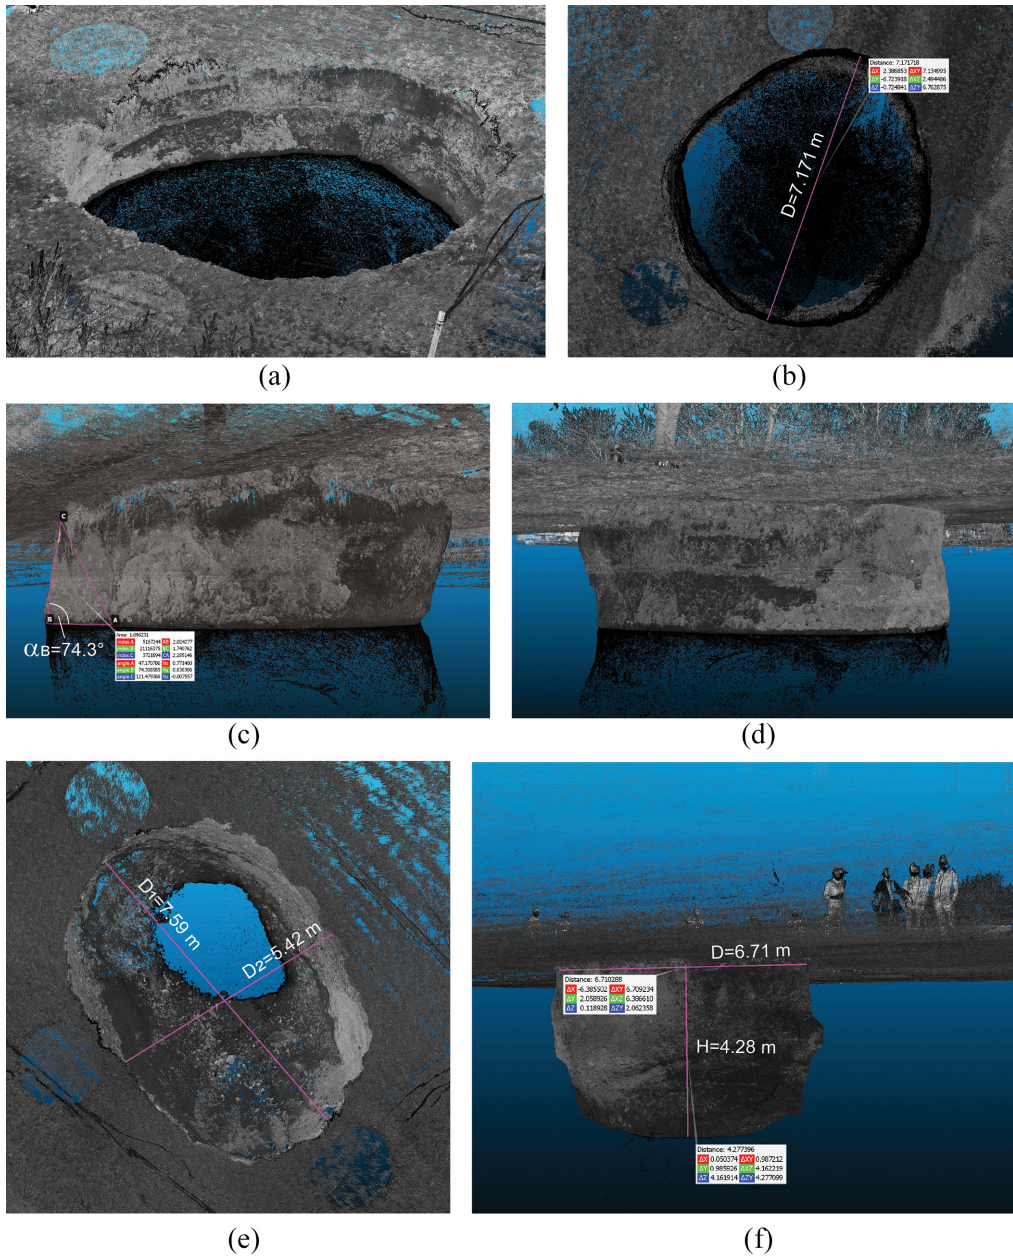
Figure 8. Examples of point cloud imagery of large sinkholes S048 ((a) to (d); 7.2 m in diameter) and S049 ((e) and (f); 7.6 m in diameter in March 2021, 8 m in December 2021; 4.28 m to water, total depth 5.6 m) in SE part of the study area in Mečenčani village, for location, see Figure 2.

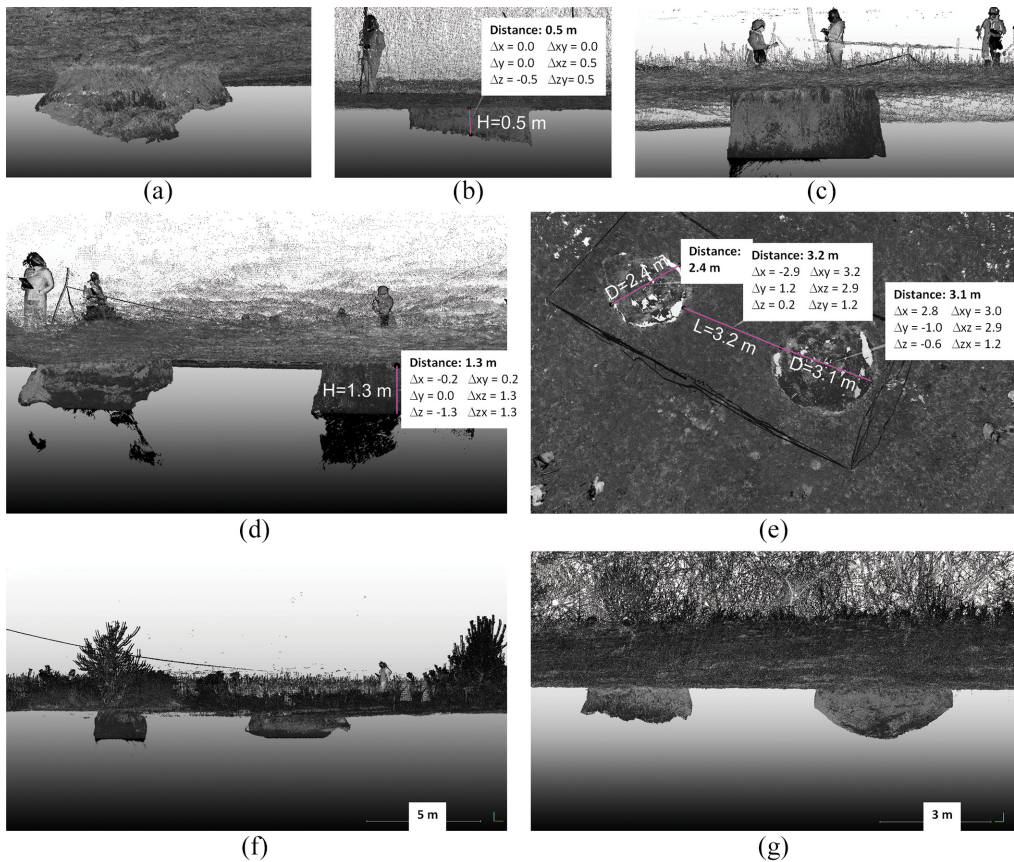
Figure 9. Examples of point cloud imagery of smaller sinkholes in NW part of the study area, NE of Borojevići village (for location, see Figure 2): (a) S012 (2.2 m in diameter), (b) S013 (2.6 m in diameter), (c) S025 (3.8 m in diameter), (d) S003 (left, largest diameter 2.9 m) and S002 (right, 3.1 m in diameter), (e) S023 (2.4 m in diameter) and S024 (3.1 m in diameter), (f) S029 (left, 2.2 m in diameter) and S028 (right, 3.9 m in diameter), and (g) S083 (left, 2.7 in diameter) and S084 (right, 3.9 m in diameter).

Smaller sinkholes, like the ones illustrated in Figure 9, dry or filled with standing water, are most common among 74 new cover-collapse sinkholes located in the NW part of the study area (Figure 2; blue symbols in Figure 6). Diameters of sinkholes in the NW part of the area vary between 0.55 m to 8.9 m, with depths between 0.3 m and 2.8 m. Figure 9

shows point cloud imagery of smaller sinkholes positioned more closely to each other than larger sinkholes from the first group. Sinkholes S012 and S013 have similar small diameters and are filled with collapsed soil and no water. While walls of S013 are nearly vertical through uniform clay, the walls of S012 show significant overhang in clayey gravel. S025 is another example of a smaller, nearly cylindrical sinkhole in clayey and fine-grained soil filled with water. Examples of double sinkholes, collapsed in close proximity, are shown in Figure 8 for the S023 and S024, S028 and S029, as well as S083 and S084 pairs.

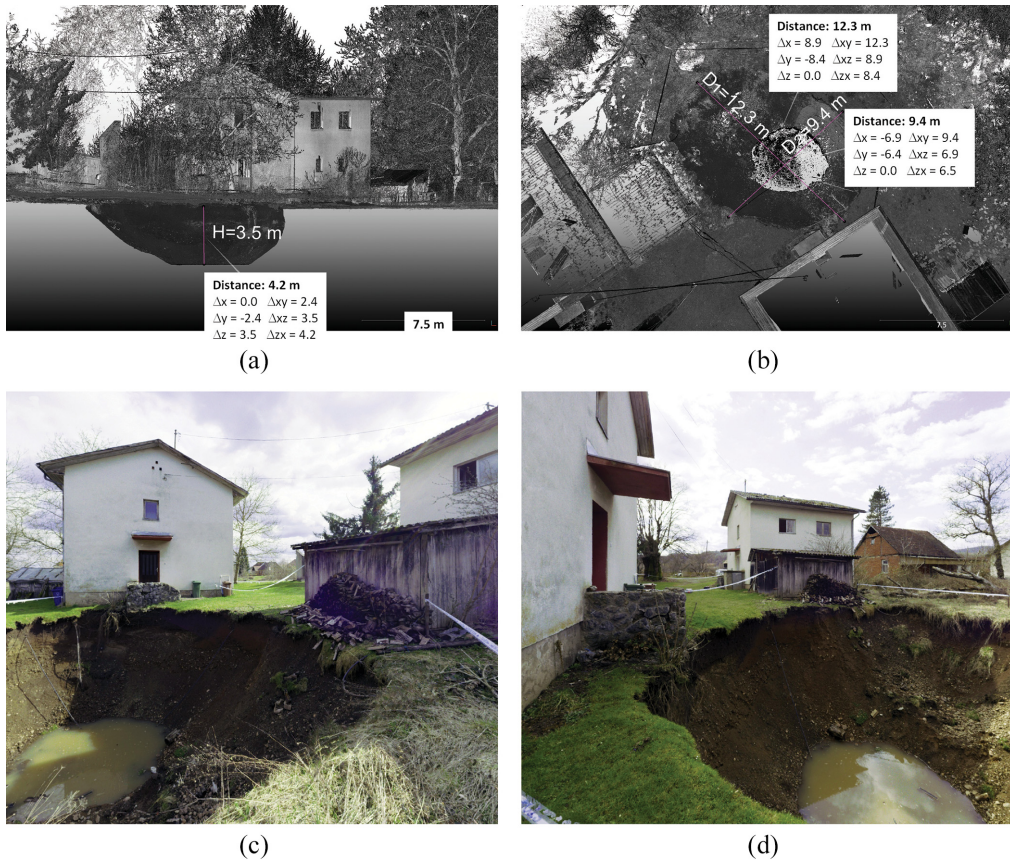
Figure 10. Sinkhole S015 near houses and infrastructure in Mečenčani (for location, see Figure 2): (a) and (b) lidar scans, (c) and (d) photographs.

While most of the sinkholes opened within the agricultural land, some sinkholes are closely related to infrastructure damage (Figure 10). Large cover-collapse sinkhole S015 collapsed between two houses on 29 December 2021 following the main shock earlier the same day. The tenant of the house next to which the S015 collapsed noted 2 smaller sinkholes, each approximately 1 m in diameter and 1 m deep, opened 6 h after the main earthquake, and subsequently combined into a large sinkhole, 7 m in diameter, within the next 12 h. S015 is the only documented case of sinkhole coalescence phenomenon in the study

area, which commonly occur in karst (Delle Rose and Parise, 2002; Margiotta et al., 2021). After approximately 2 weeks, the sinkhole reached its final shape and dimensions (diameter of 12.3 m, 3.6 m depth) that were retained for the following 10 months. S015 was the largest among several sinkholes remediated by filling with gravel, geosynthetics, and soil in November 2021.

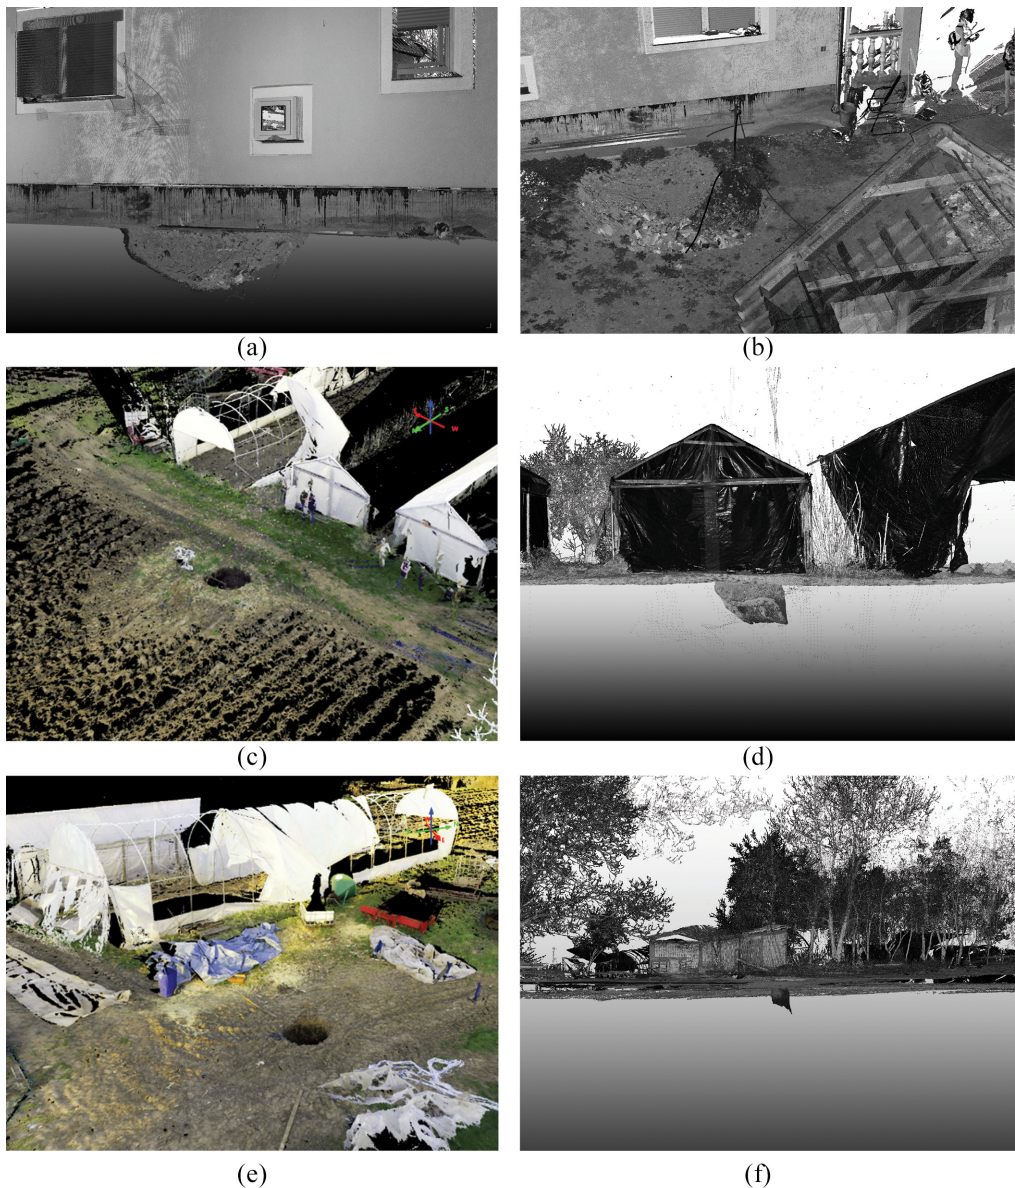
Figure 11. Lidar images of sinkholes S053 ((a) and (b), 3.2 m in diameter), S054 ((c) and (d), 2.0 m in diameter), and S055 ((e) and (f), 1.5 m in diameter) on Mečenčani family farmland (for location, see Figure 2).

Furthermore, 3 sinkholes collapsed in a nearby family farm in Mečenčani (Figure 11), S053, S054, and S055 (S054 and S055 are circular sinkholes with a small diameter, quite deep and have vertical walls).

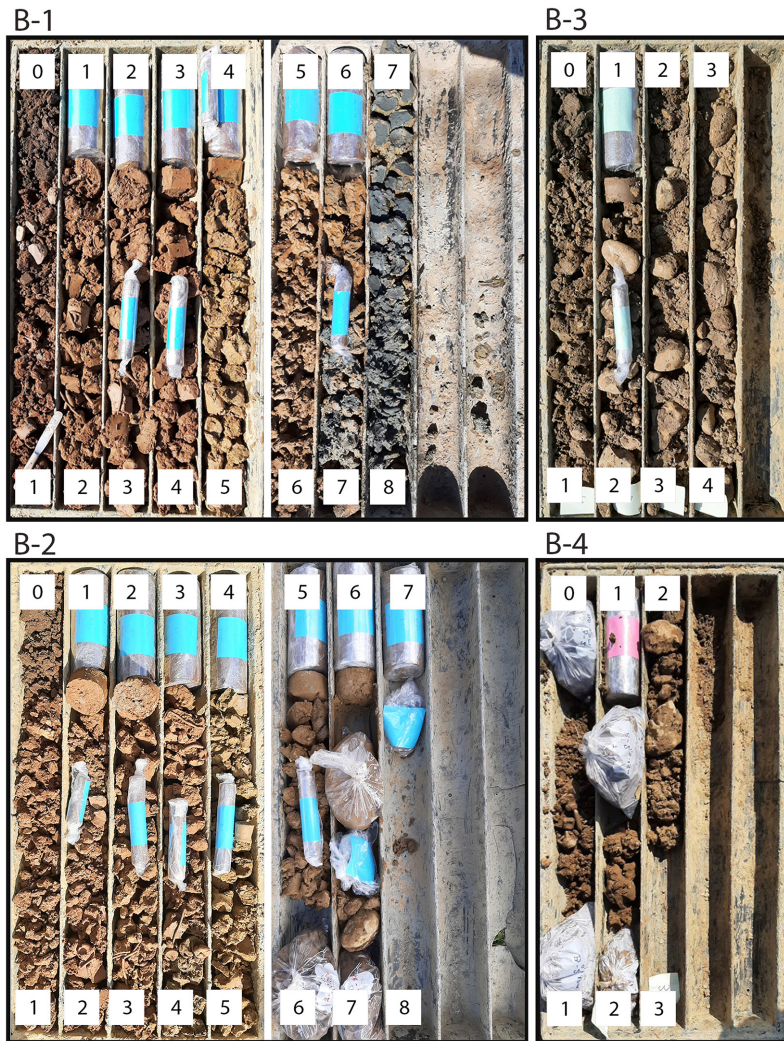
Figure 12. Soil core and sampling locations from boreholes B-1 to B-4 (photo by Evelina Oršulić). Numbers indicate depth in meters.

a depth of 8.0 and 7.6 m, respectively. Below these depths, further advancement was no longer possible either because of the presence of very stiff marly clay or the increased content of gravel-size particles (Figure 12). Boreholes B-3 and B-4 were drilled close to the sinkholes S009 and S040 in the NW part of the study area, closer to Sunja river. Drilling ended at depths of only 4.0 and 2.5 m, respectively. Below these depths, further advancement was no longer possible as the content of gravel-size particles increased (Figure 12).

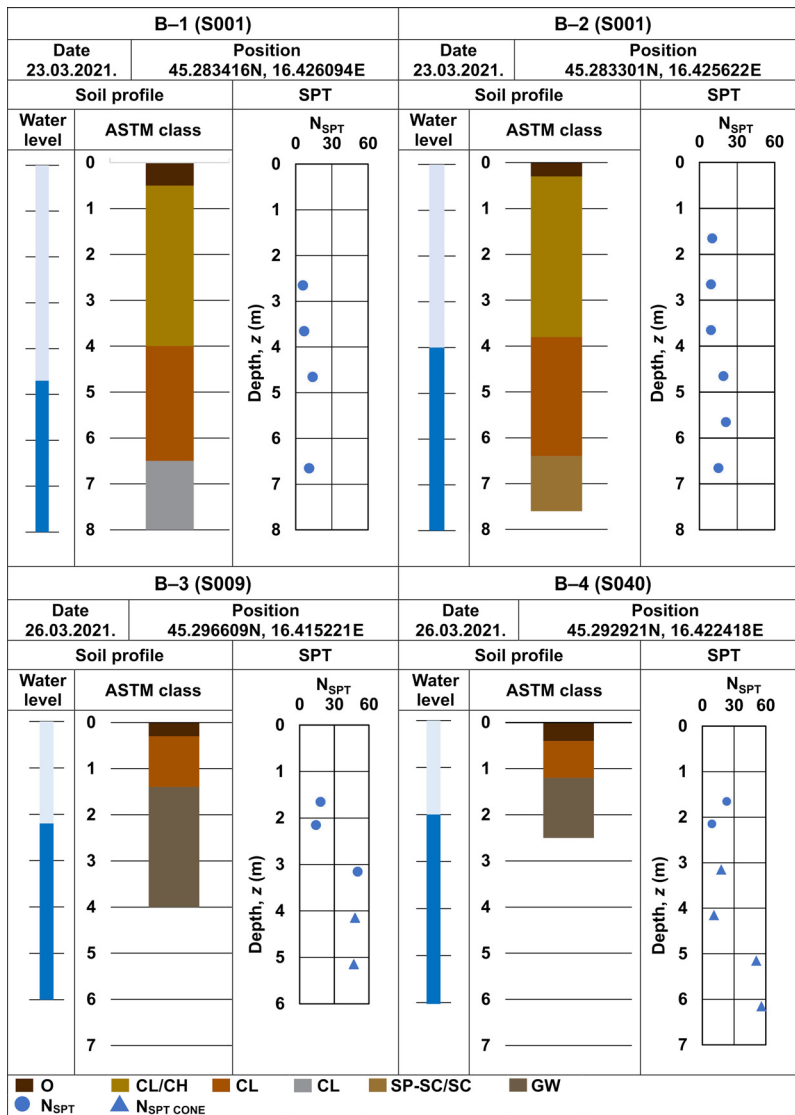
Figure 13. Boring logs for boreholes B-1 through B-4.

SPTs were performed in all boreholes at approximately 1.0 m intervals by using a mechanical drive-weight unit with a standard donut-type hammer according to ASTM standard (ASTM D1586-11, 2011)—weight 63.5 kg, hammer travel distance 760 mm. The split-spoon sampler with a length of 482 mm, inside diameter of 34.93 mm, and outside diameter of 50.8 mm was connected to the drive unit by “A” size rods (outside diameter 41.2 mm and inside diameter 28.5 mm). The sampler was driven to the bottom of the borehole with hammer blows. The number of blows applied were counted for three 150 mm increments (450 mm of total advance). The sum of the number of blows required for the second and third 150 mm increment of penetration is denoted by N_{SPT} (raw data without any correction). The same procedure was used for conical probing. A conical tip (60.0°, diameter 50.8 mm) was used instead of the split-spoon sampler. It was driven with the same energy as SPT. In this case, the sum of the number of blows required for the second

and third 150 mm increments of penetration is denoted by $N_{SPT\ CONE}$. A conical probe was used in boreholes B-3 and B-4 below the depths of 4.0 or 2.5 m, respectively. Further penetration below the depths of 5.8 and 6.5 m was not possible even with the use of the conical probe (Figure 13). Groundwater tables (GWTs) in boreholes B-1 and B-2 were initially detected at 4.7 and 4.0 m below the ground level, respectively. GWTs rose shortly after the drilling was completed, whereby the subsequent GWTs in both boreholes closely corresponded to the GWT inside the sinkhole S001.

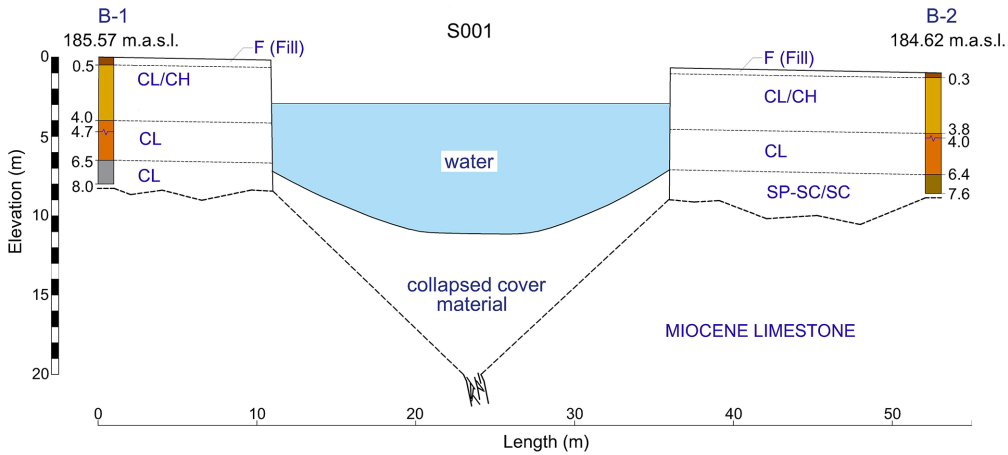
Figure 14. Vertical cross-section through sinkhole S001 and boreholes B-1 and B-2.

Based on the field description and identification, and laboratory test results, soil samples were classified according to visual and manual procedures (ASTM D2488-17, 2017) and the Unified Soil Classification System (USCS) (ASTM D2487-17, 2017). Figure 13 shows boring logs for boreholes B-1 through B-4, while a cross-section through sinkhole S001 is depicted in Figure 14.

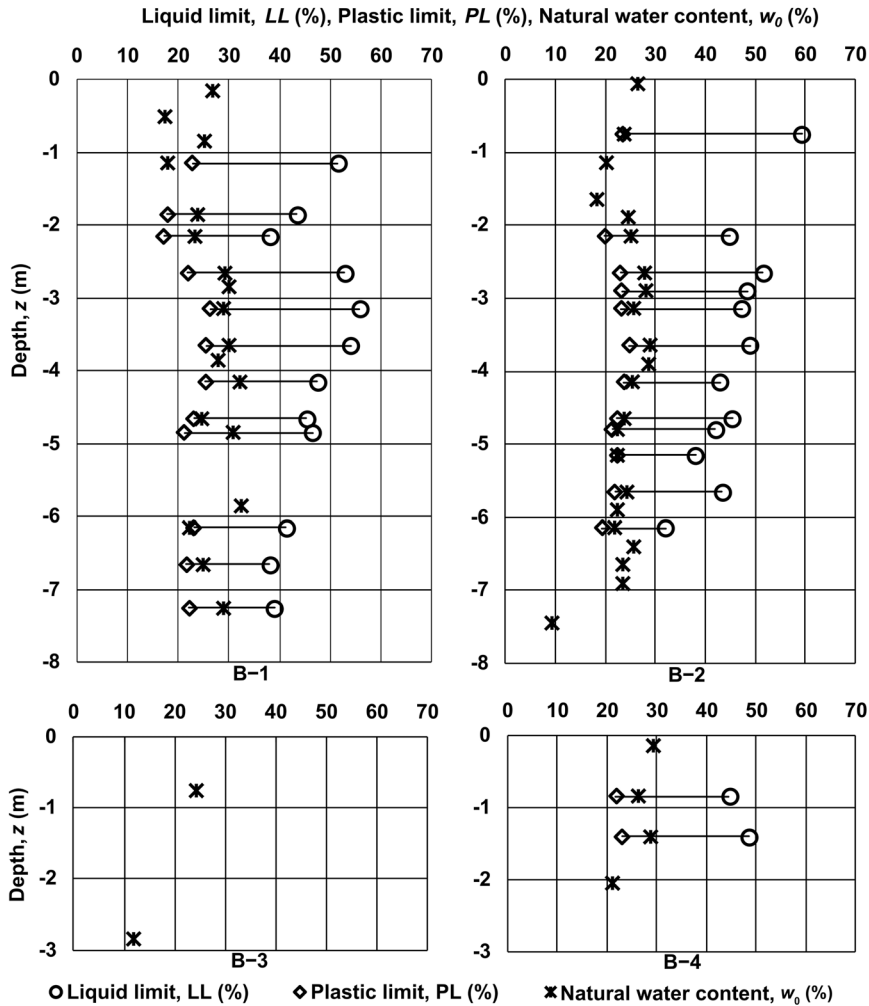
Figure 15. Atterberg limits and natural water content versus depth for boreholes B-1 to B-4.

Figure 15 depicts variation of Atterberg limits and natural water contents versus depth, while Figure 16 shows grain size distribution curves for soils collected from boreholes B-1 to B-4.

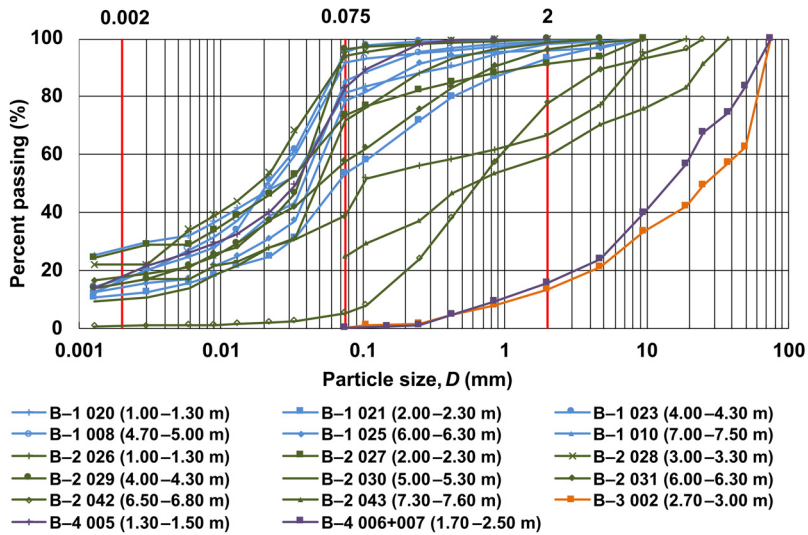
Figure 16. Grain size distribution curves for soils collected from boreholes B-1 to B-4.

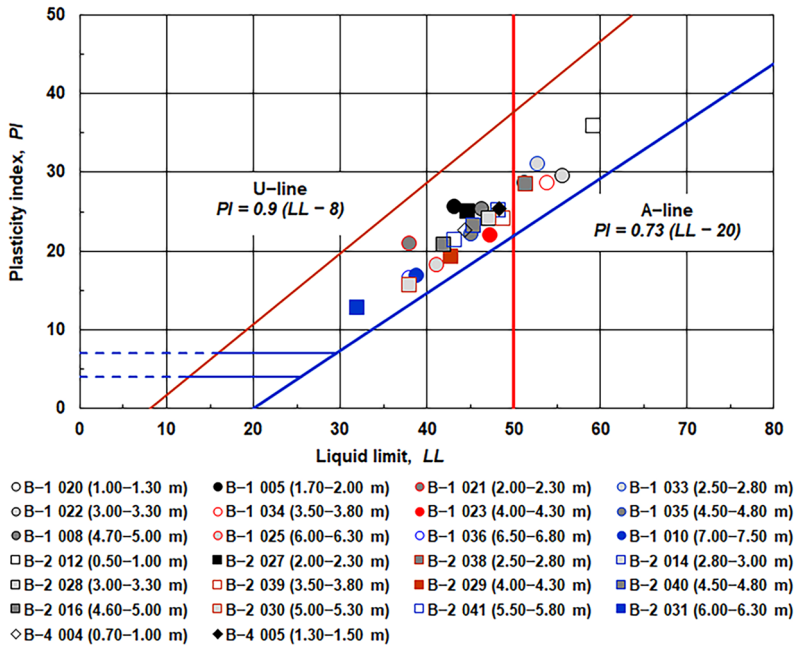
Figure 17. Casagrande plasticity chart for soils collected from boreholes B-1 (circles), B-2 (squares), and B4 (diamonds).

Furthermore, plasticity indices and liquid limits for various soil samples collected from boreholes B-1, B-2, B-3, and B-4 are depicted in the Casagrande plasticity chart shown in Figure 17, thus indicating that most of the soil samples are in the area of low-plasticity clays with few exceptions that fall into the range of high-plasticity clays.

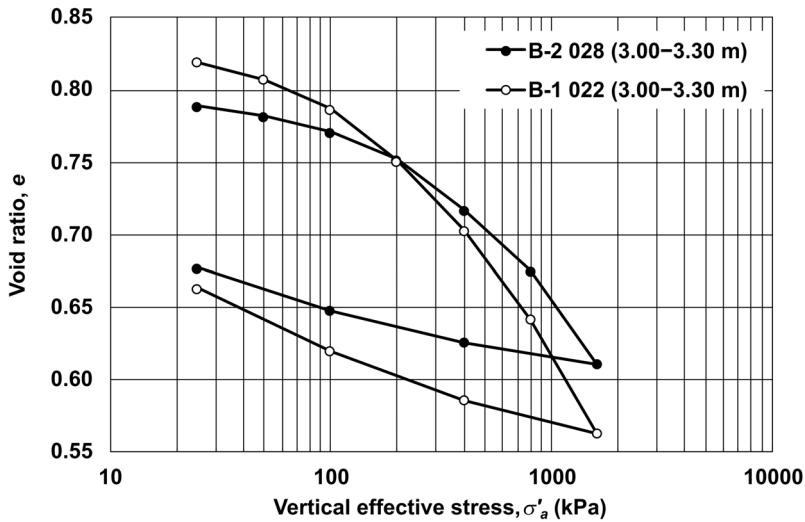
Figure 18. Results of oedometer tests performed on sample nos 022 and 028 that were collected from depths ranging between 3.0 and 3.3 m (boreholes B-1 and B-2).

Oedometer tests were performed on saturated samples. Figure 18 shows the results obtained from the sample nos 022 (B-1) and 028 (B-2). The tests were performed in

accordance with the ASTM standard (ASTM D2435-11, 2011). Assessment of sample disturbance according to the procedure suggested by Lunne et al. (1997) indicated that both samples are of very good to excellent quality. Consequently, vertical effective preconsolidation stresses (σ'_c) for both samples, which are reported in Table 1, were determined based on Casagrande's procedure. The corresponding OCR values were determined by using the geostatic vertical effective stresses that were computed based on the relevant average unit weights provided in Table 1. Two different GWTs were used, one registered during drilling and the other one corresponding to the water level inside the sink-hole S001, as described previously. This resulted in two different OCR values reported in Table 1.

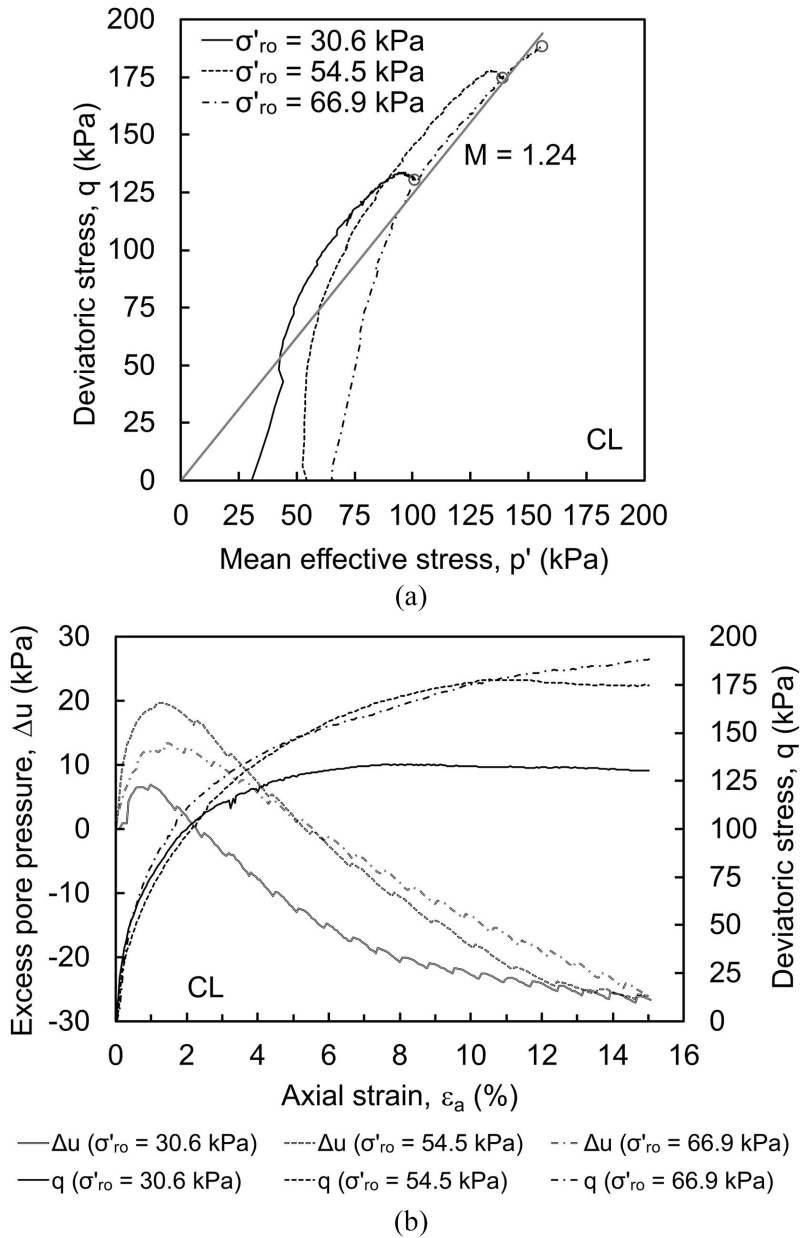
Figure 20. Results of CIUC tests performed on sample no. 027 (2.0–2.3 m, borehole B-2): (a) excess pore pressure and deviatoric stress versus axial strain and (b) effective stress paths.

Results are depicted in Figures 19 to 21 whereby deviatoric and mean effective stresses are denoted by q and p' , respectively.

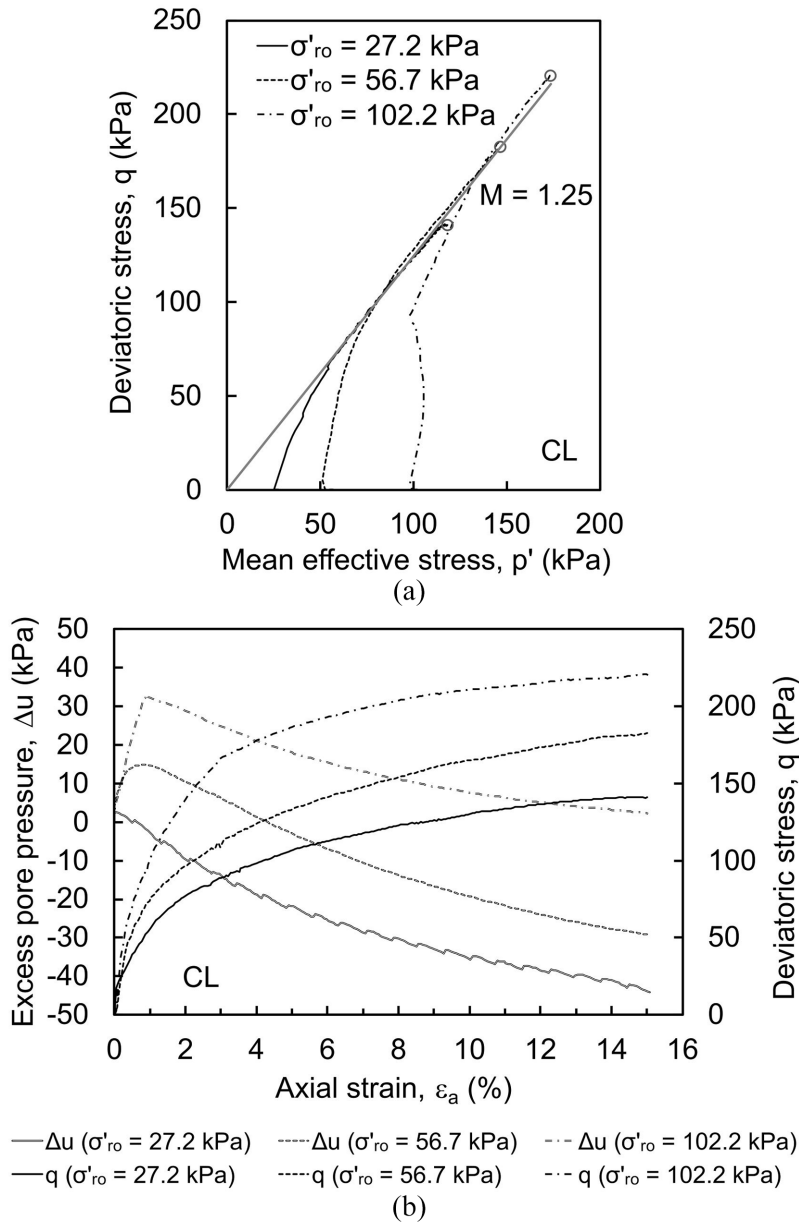
Figure 21. Results of CIUC tests performed on sample no. 028 (3.0–3.3 m, borehole B-2): (a) excess pore pressure and deviatoric stress versus axial strain and (b) effective stress paths.

For more complete interpretation of test results, the mean effective preconsolidation stress (p'_c) and corresponding OCR (OCR_p) were determined for sample no. 28, for which both oedometer and CIUC test results are available. The former is given by

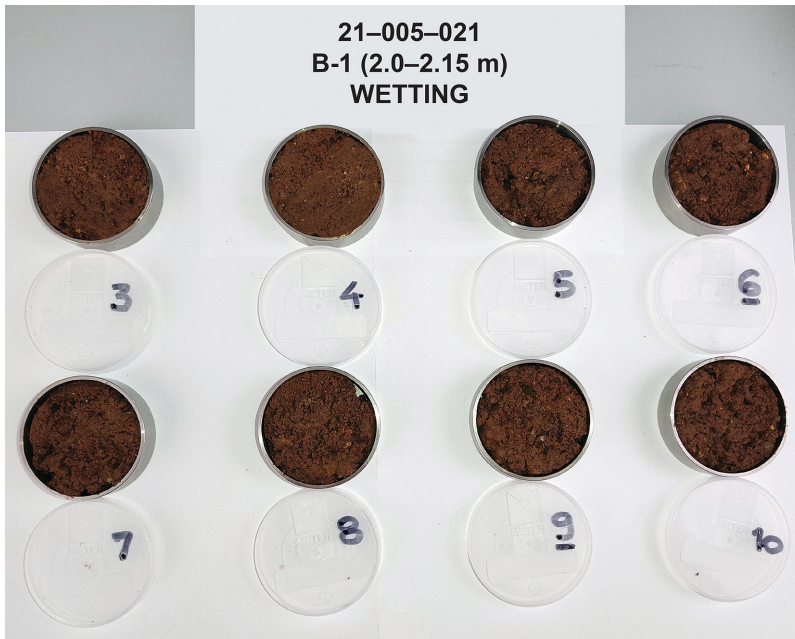
Figure 22. Specimens prepared for measurement of SWRC in a WP4C device: wetting branch of the SWRC, multiple-specimen method.

Within the scope of this study, SWRCs were measured in accordance with ASTM D6836-16 (2016) Method D by using the “chilled mirror hygrometer” or chilled mirror dew point method. WP4C potentiometer (METER, 2021), which is suitable for making suction measurements in the range of 0.1 to 300 MPa, was used. WP4C potentiometer determines the relative humidity of the air above a sample in a sealed chamber. The amount of water present in the soil for the purpose of drawing SWRC can be expressed in terms of a gravimetric water content w , volumetric water content θ , or degree of saturation S . The corresponding SWRCs are often designated as SWRC- w , SWRC- θ , and SWRC- S , respectively. SWRC in terms of total suction, which is sum of matric and osmotic suctions, is obtained from Method D whereby total suction is computed using the Kelvin equation (ASTM D6836-16, 2016). The suction for the SWRC can be expressed as a pressure ψ or as a pressure head h_ψ .

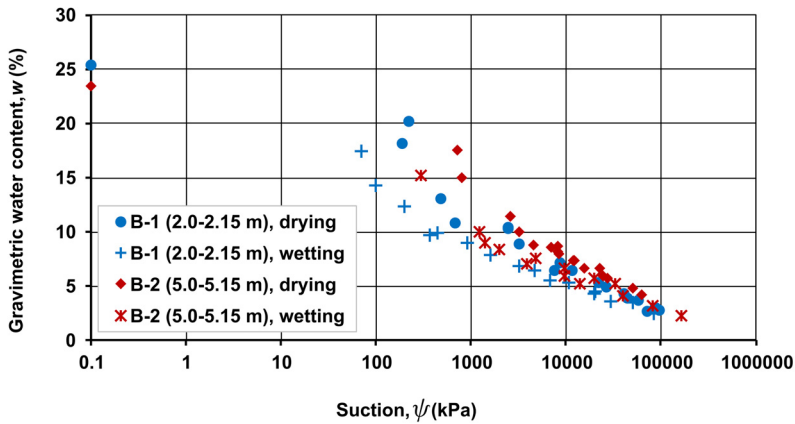
Figure 23. Results of SWRC measurements including drying and wetting paths plotted in the gravimetric water content versus the logarithm of the suction coordinate system (SWRC-w).

Results for samples no. 021 (B-1) and 030 (B-2), including drying and wetting paths, are depicted in Figures 23 and 24. In Figure 23, data are plotted in the gravimetric water

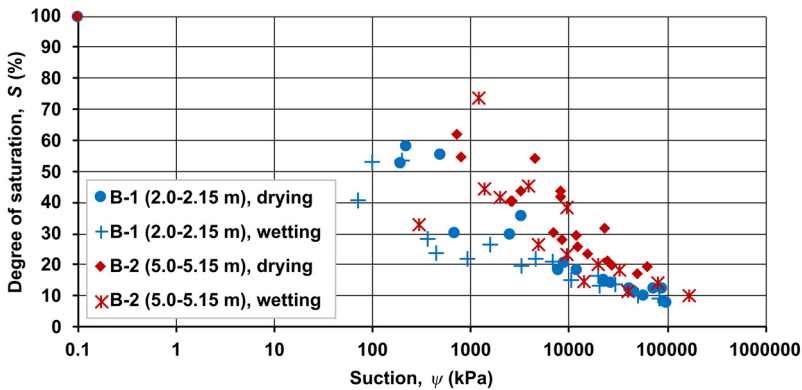
Figure 24. Results of SWRC measurements including drying and wetting paths plotted in the degree of saturation versus the logarithm of the suction coordinate system (SWRC-S).

content versus logarithm of suction coordinate system, while in Figure 24, the same data are plotted in the degree of saturation (S) versus logarithm of suction coordinate system.
