Geotechnical reconnaissance of an extensive cover-collapse sinkhole phenomena of 2020-2021 Petrinja earthquake sequence (Central Croatia)

Geotechnical reconnaissance of an extensive cover-collapse sinkhole phenomena of 2020–2021 Petrinja earthquake sequence (Central Croatia)

Earthquake Spectra

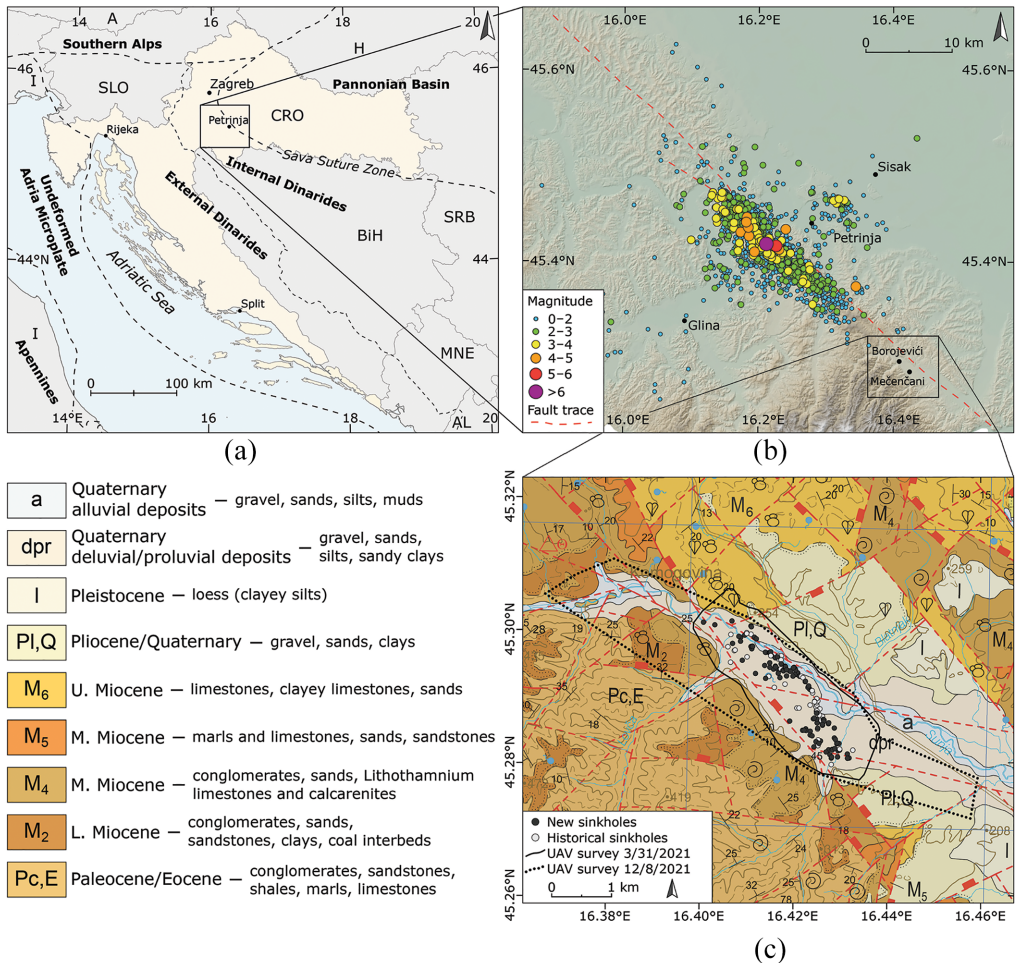
Figure 1. (a) Map of Croatia with the earthquake epicentral region; (b) epicenters of earthquakes recorded within first 2 weeks of 2020–2021 Petrinja earthquake sequence (Herak and Herak, 2021, personal communication) and the fault trace (Tomac et al., 2021); and (c) detail of geological map (Šikić, 2014) showing locations of new and historical cover-collapse sinkholes and study area covered by UAV surveys of 31 March 2021 (full black line) and 8 December 2021 (dotted black line).

The bulk of the Petrinja sequence epicenters are elongated in the NW–SE direction across roughly 20 km in length and 2–4 km in width (Figure 1b), within the Hrastovica Hill between the Kupa and Petrinjčica rivers. The main cluster is slightly asymmetric, with aftershocks protruding to the SW, especially in the central zone. A distinct NW–SE oriented sub-cluster of events in the length of about 9 km, separated from the main Hrastovica Hill cluster, is observed to the NE between Petrinja and Sisak. The mainshock

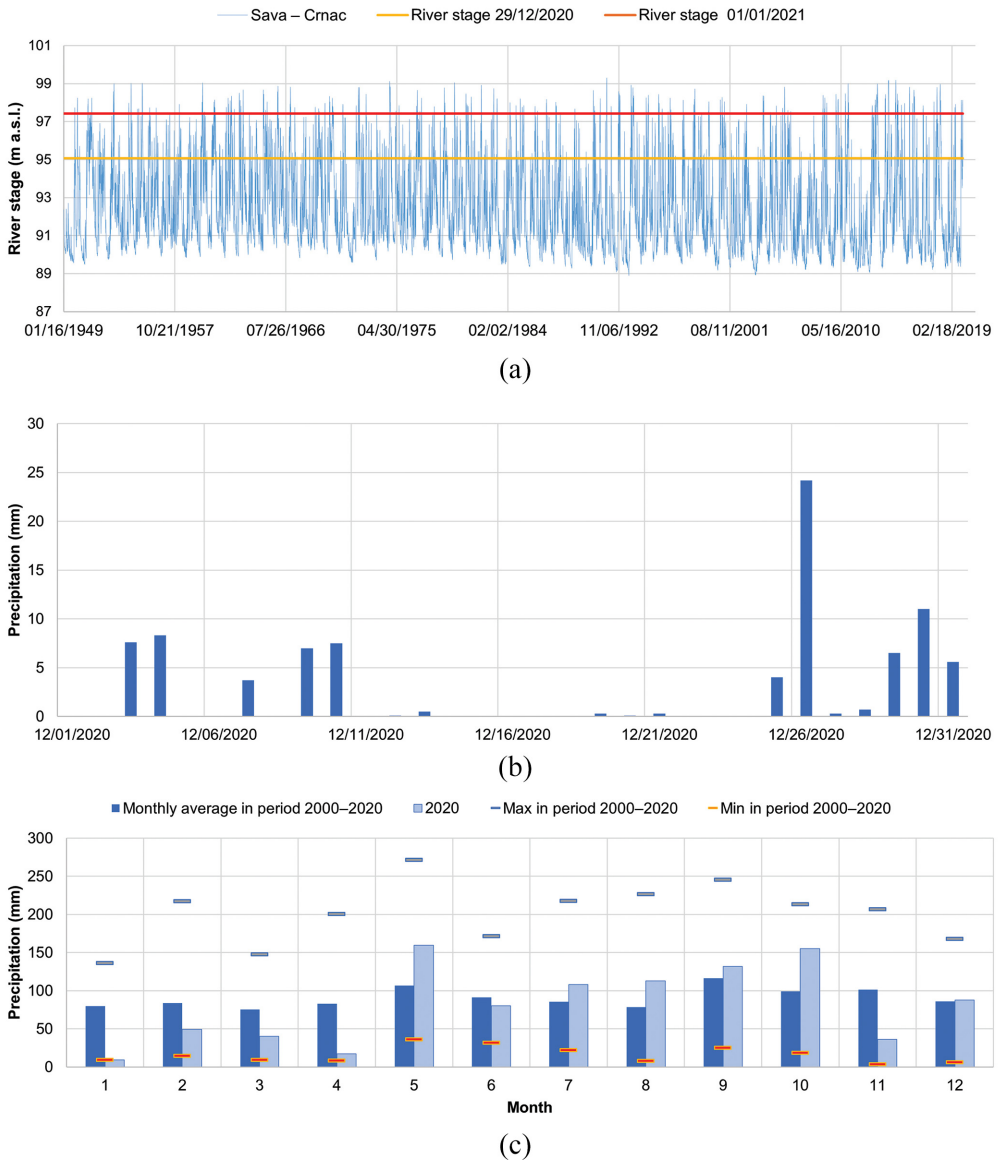
Figure 3. (a) Sava river stages during the 1949–2019 period at the gauging station in Crnac with stages on 29 December 2020 (yellow line) and 1 January 2021 (red line), (b) daily precipitation at the Mečenčani rainfall station during December 2020, and (c) average, maximum, and minimum precipitation per month in 2000–2020 period in Mečenčani.

To assess the hydrological conditions in Mečenčani and Borojevići area, the time series of stage data on the Sava River from 1949–2019 were analyzed (Figure 3a). The gauging station is located approximately 17 km to the north of the investigated area. The high values of stage in Sava River appeared due to heavy rainfall in the second half of December (Figure 3b). Analysis of the stage data on the Sava River shows that the earthquake occurred during high waters, and at a time of rapidly increasing water levels (Figure 3a), the water level in the aquitard was very close to the surface, and in the underlying karst aquifer, artesian conditions prevailed (Tomac et al., 2021). In Figure 3c, blue lines represent maximum precipitation and red lines minimum precipitation in the 2000–2020 period. However, the monthly value of precipitation in December 2020 does not deviate from the average precipitation in December recorded in the 2000–2020 period (Figure 3c).

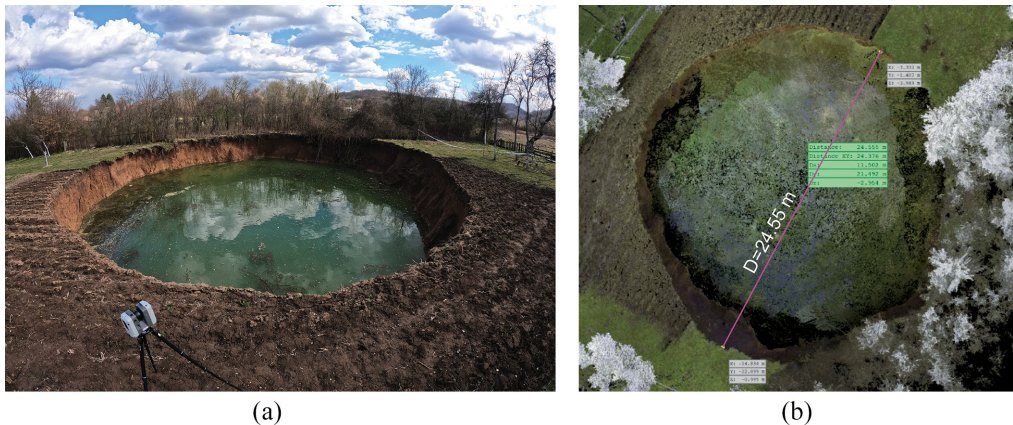
Figure 7. The largest sinkhole S001 in Mečenčani village, for location see Figure 2, (a) photograph by Ivica Pavičić and (b) lidar scan.

and more than 24 hours before the strongest M_w 4.9 aftershock that took place at 6:01 PM local time on 6 January. When it was first observed, the sinkhole was about 3 m in diameter and then gradually widened to 15 m in diameter 24 hours later due to failed walls, which remained subvertical. Figure 8 shows 2 other relatively large sinkholes (S048 and S049), in Mečenčani with a diameter of about 7 to 8 m each. S048 walls are not vertical as measured above the water level, unlike most sinkholes in the area. Its walls overhang and indicate an inclined tubular collapse of the cover with a nearly constant diameter.

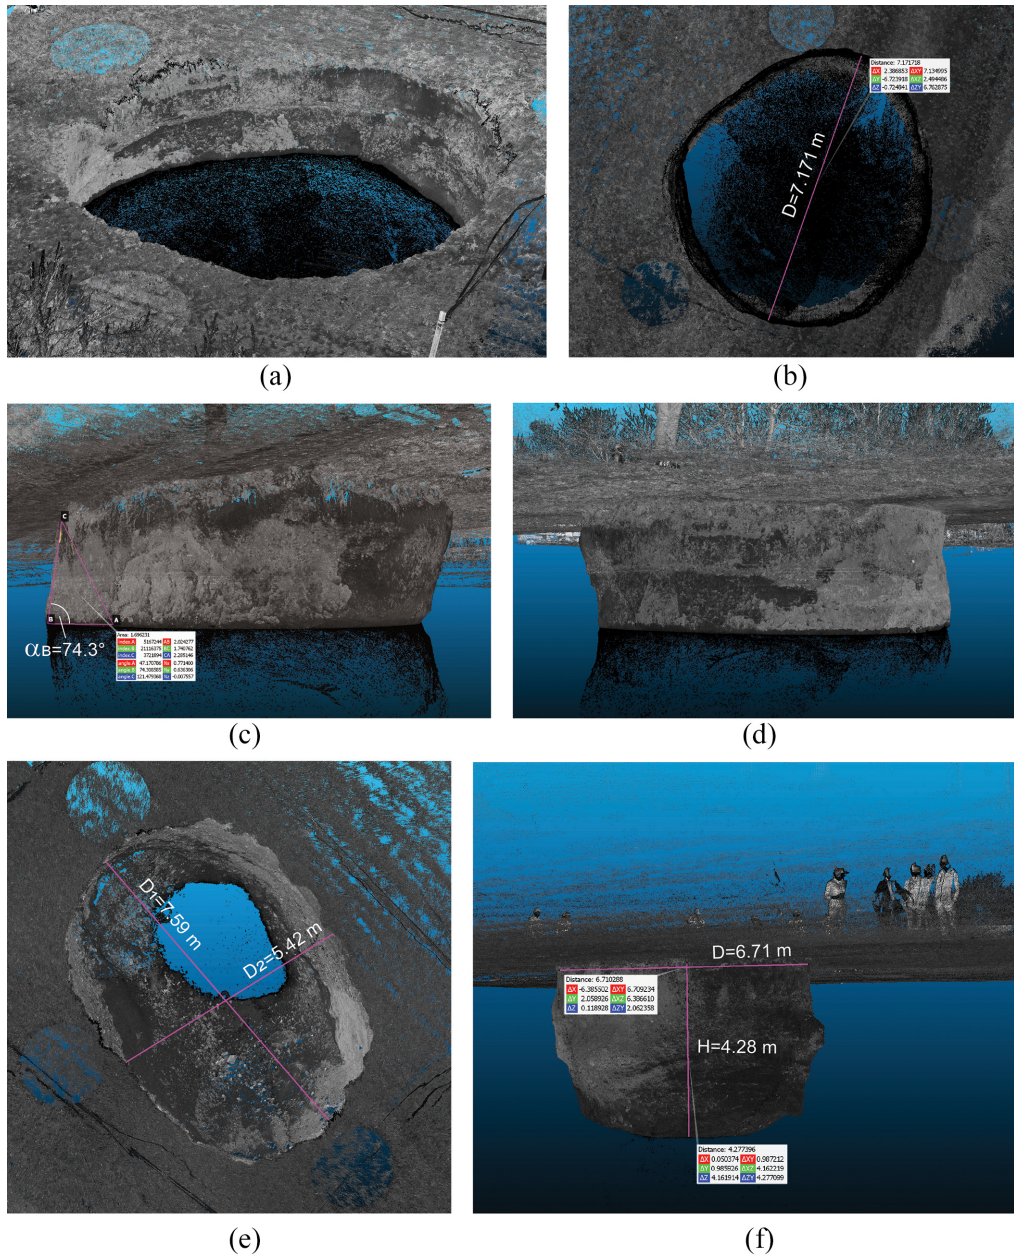
Figure 8. Examples of point cloud imagery of large sinkholes S048 ((a) to (d); 7.2 m in diameter) and S049 ((e) and (f); 7.6 m in diameter in March 2021, 8 m in December 2021; 4.28 m to water, total depth 5.6 m) in SE part of the study area in Mečenčani village, for location, see Figure 2.

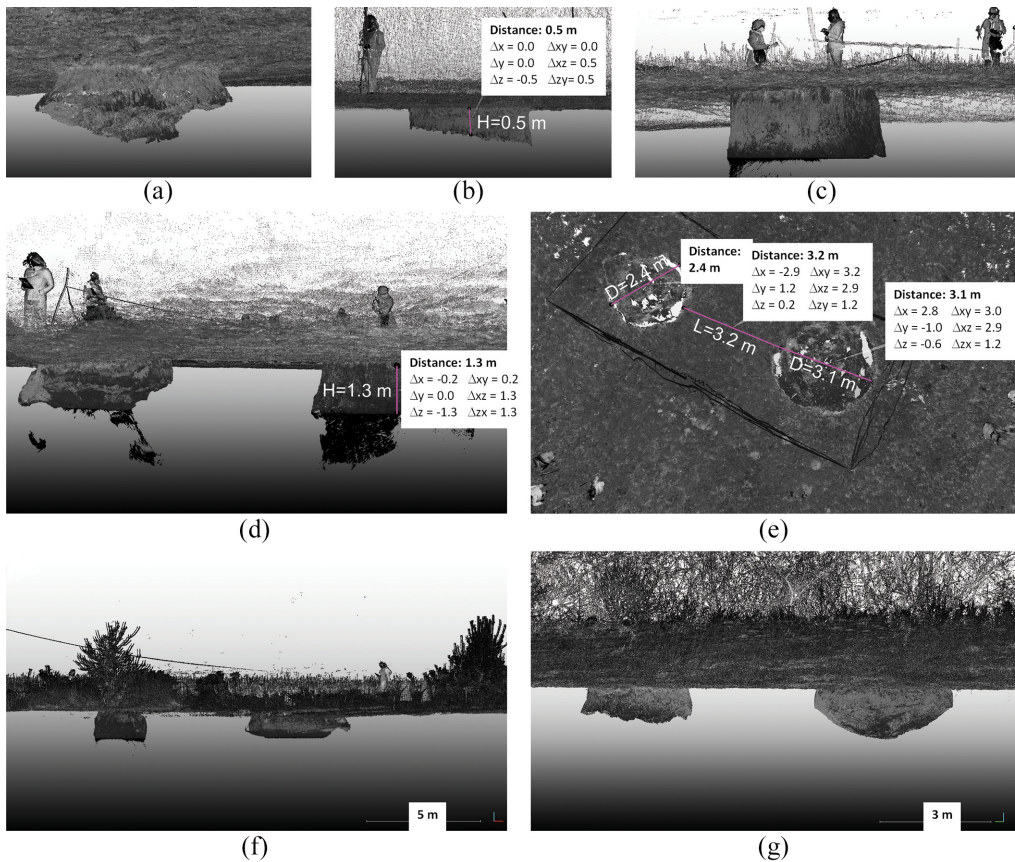
Figure 9. Examples of point cloud imagery of smaller sinkholes in NW part of the study area, NE of Borojevići village (for location, see Figure 2): (a) S012 (2.2 m in diameter), (b) S013 (2.6 m in diameter), (c) S025 (3.8 m in diameter), (d) S003 (left, largest diameter 2.9 m) and S002 (right, 3.1 m in diameter), (e) S023 (2.4 m in diameter) and S024 (3.1 m in diameter), (f) S029 (left, 2.2 m in diameter) and S028 (right, 3.9 m in diameter), and (g) S083 (left, 2.7 in diameter) and S084 (right, 3.9 m in diameter).

Smaller sinkholes, like the ones illustrated in Figure 9, dry or filled with standing water, are most common among 74 new cover-collapse sinkholes located in the NW part of the study area (Figure 2; blue symbols in Figure 6). Diameters of sinkholes in the NW part of the area vary between 0.55 m to 8.9 m, with depths between 0.3 m and 2.8 m. Figure 9

shows point cloud imagery of smaller sinkholes positioned more closely to each other than larger sinkholes from the first group. Sinkholes S012 and S013 have similar small diameters and are filled with collapsed soil and no water. While walls of S013 are nearly vertical through uniform clay, the walls of S012 show significant overhang in clayey gravel. S025 is another example of a smaller, nearly cylindrical sinkhole in clayey and fine-grained soil filled with water. Examples of double sinkholes, collapsed in close proximity, are shown in Figure 8 for the S023 and S024, S028 and S029, as well as S083 and S084 pairs.

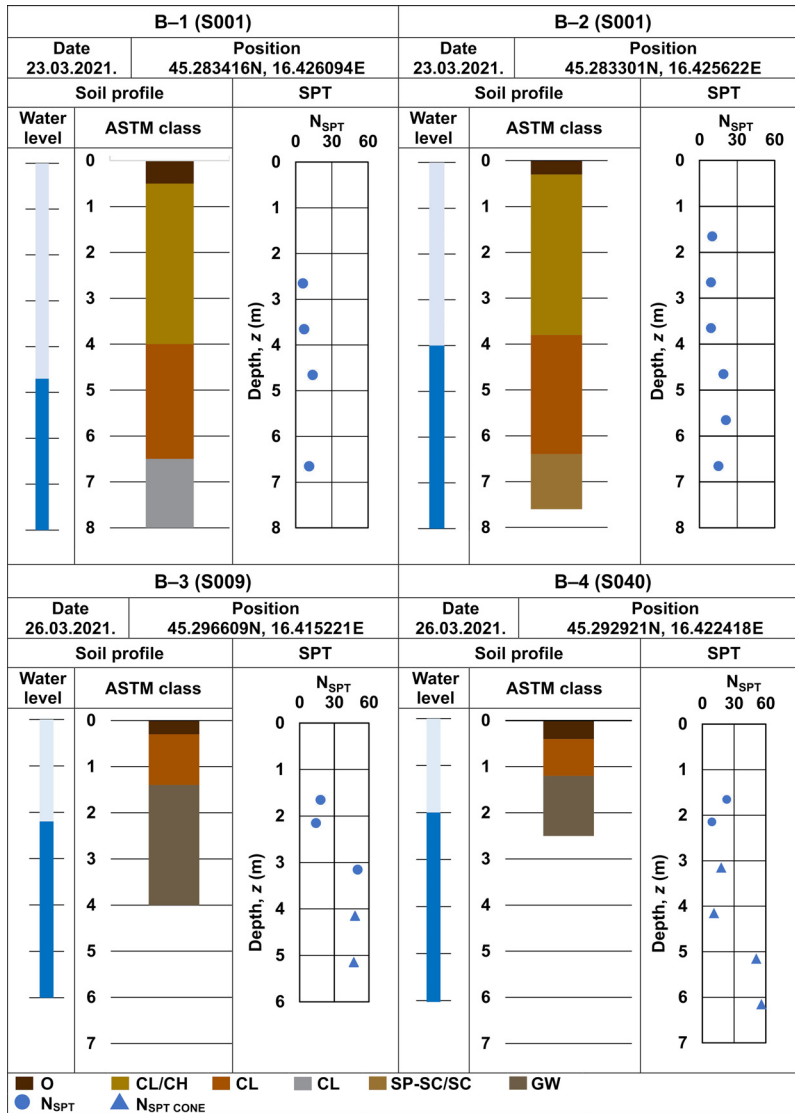
Figure 13. Boring logs for boreholes B-1 through B-4.

SPTs were performed in all boreholes at approximately 1.0 m intervals by using a mechanical drive-weight unit with a standard donut-type hammer according to ASTM standard (ASTM D1586-11, 2011)—weight 63.5 kg, hammer travel distance 760 mm. The split-spoon sampler with a length of 482 mm, inside diameter of 34.93 mm, and outside diameter of 50.8 mm was connected to the drive unit by “A” size rods (outside diameter 41.2 mm and inside diameter 28.5 mm). The sampler was driven to the bottom of the borehole with hammer blows. The number of blows applied were counted for three 150 mm increments (450 mm of total advance). The sum of the number of blows required for the second and third 150 mm increment of penetration is denoted by N_{SPT} (raw data without any correction). The same procedure was used for conical probing. A conical tip (60.0°, diameter 50.8 mm) was used instead of the split-spoon sampler. It was driven with the same energy as SPT. In this case, the sum of the number of blows required for the second

and third 150 mm increments of penetration is denoted by $N_{SPT CONE}$. A conical probe was used in boreholes B-3 and B-4 below the depths of 4.0 or 2.5 m, respectively. Further penetration below the depths of 5.8 and 6.5 m was not possible even with the use of the conical probe (Figure 13). Groundwater tables (GWTs) in boreholes B-1 and B-2 were initially detected at 4.7 and 4.0 m below the ground level, respectively. GWTs rose shortly after the drilling was completed, whereby the subsequent GWTs in both boreholes closely corresponded to the GWT inside the sinkhole S001.

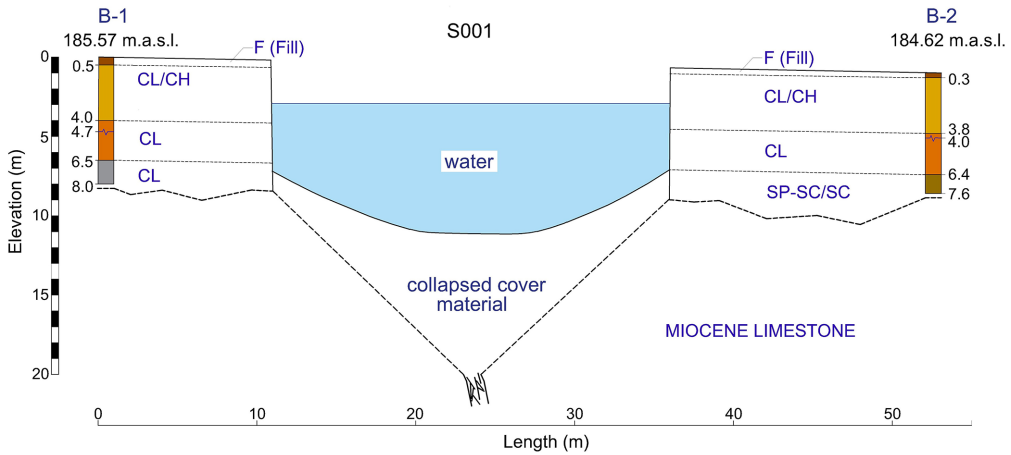
Figure 14. Vertical cross-section through sinkhole S001 and boreholes B-1 and B-2.

Based on the field description and identification, and laboratory test results, soil samples were classified according to visual and manual procedures (ASTM D2488-17, 2017) and the Unified Soil Classification System (USCS) (ASTM D2487-17, 2017). Figure 13 shows boring logs for boreholes B-1 through B-4, while a cross-section through sinkhole S001 is depicted in Figure 14.

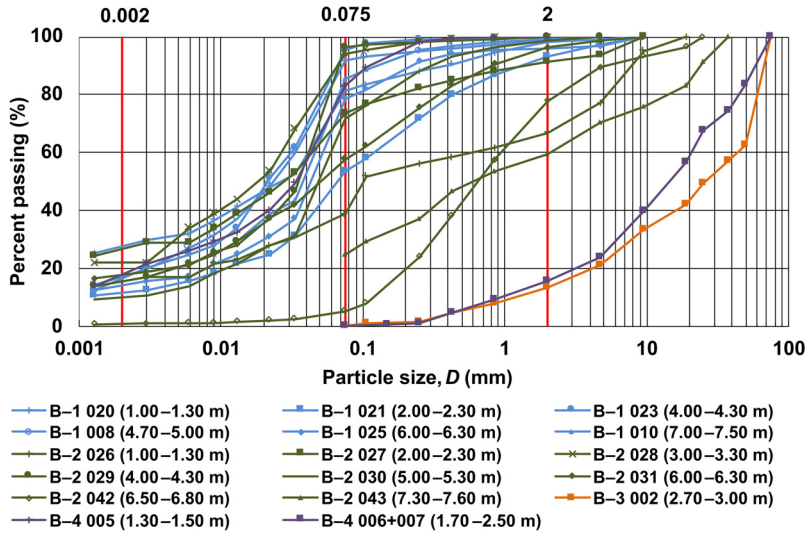
Figure 16. Grain size distribution curves for soils collected from boreholes B-1 to B-4.

Figure 15 depicts variation of Atterberg limits and natural water contents versus depth, while Figure 16 shows grain size distribution curves for soils collected from boreholes B-1 to B-4.

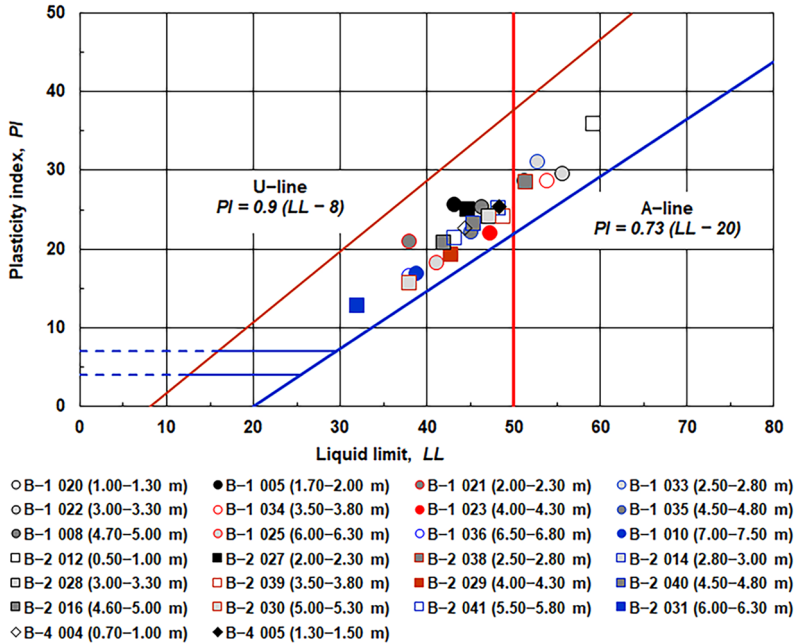
Figure 17. Casagrande plasticity chart for soils collected from boreholes B-1 (circles), B-2 (squares), and B4 (diamonds).

Furthermore, plasticity indices and liquid limits for various soil samples collected from boreholes B-1, B-2, B-3, and B-4 are depicted in the Casagrande plasticity chart shown in Figure 17, thus indicating that most of the soil samples are in the area of low-plasticity clays with few exceptions that fall into the range of high-plasticity clays.

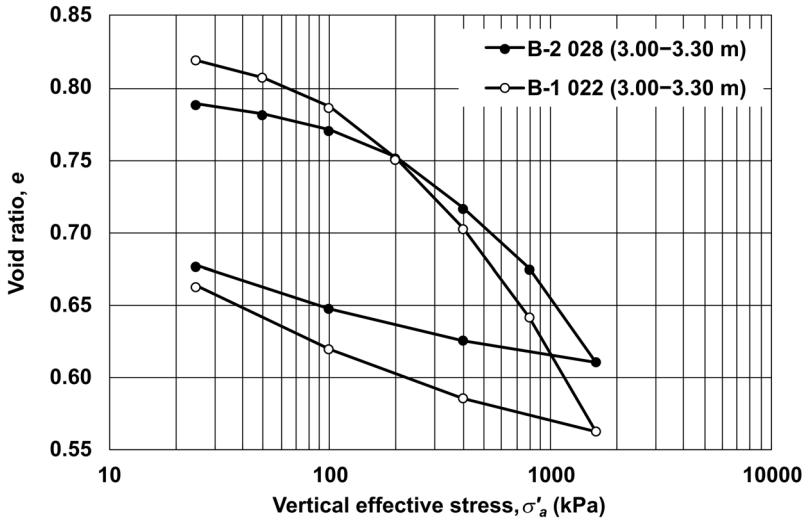
Figure 18. Results of oedometer tests performed on sample nos 022 and 028 that were collected from depths ranging between 3.0 and 3.3 m (boreholes B-1 and B-2).

Oedometer tests were performed on saturated samples. Figure 18 shows the results obtained from the sample nos 022 (B-1) and 028 (B-2). The tests were performed in

accordance with the ASTM standard (ASTM D2435-11, 2011). Assessment of sample disturbance according to the procedure suggested by Lunne et al. (1997) indicated that both samples are of very good to excellent quality. Consequently, vertical effective preconsolidation stresses (σ'_c) for both samples, which are reported in Table 1, were determined based on Casagrande's procedure. The corresponding OCR values were determined by using the geostatic vertical effective stresses that were computed based on the relevant average unit weights provided in Table 1. Two different GWTs were used, one registered during drilling and the other one corresponding to the water level inside the sink-hole S001, as described previously. This resulted in two different OCR values reported in Table 1.

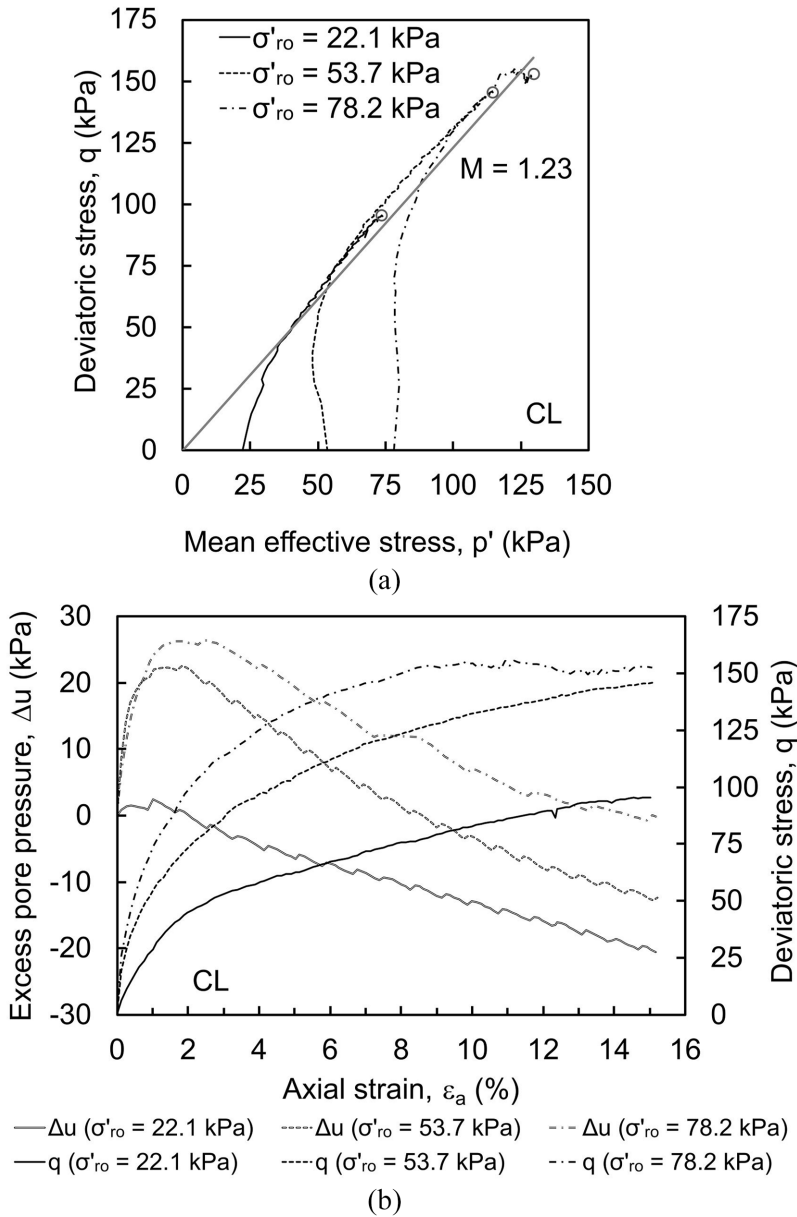
Figure 19. Results of CIUC tests performed on sample no. 023 (4.0–4.3 m, borehole B-1): (a) excess pore pressure and deviatoric stress versus axial strain and (b) effective stress paths.

Results are depicted in Figures 19 to 21 whereby deviatoric and mean effective stresses are denoted by q and p' , respectively.

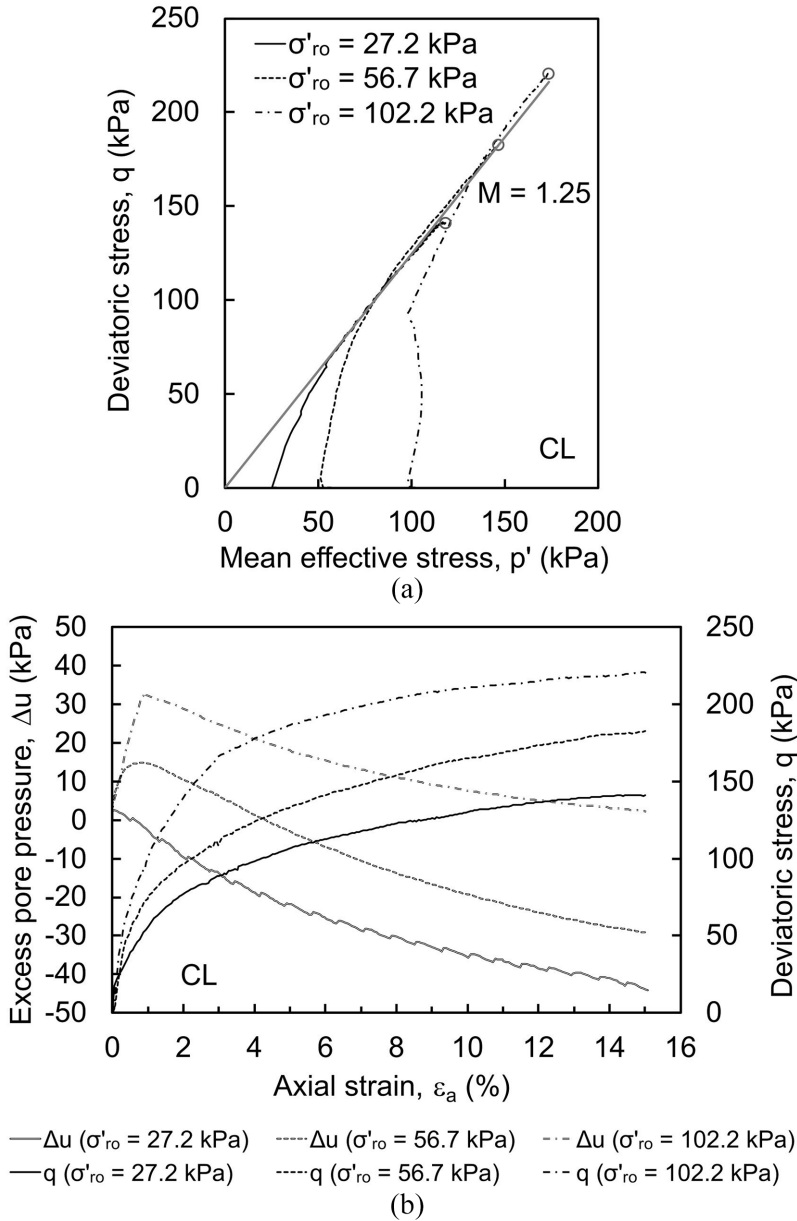
Figure 21. Results of CIUC tests performed on sample no. 028 (3.0–3.3 m, borehole B-2): (a) excess pore pressure and deviatoric stress versus axial strain and (b) effective stress paths.

For more complete interpretation of test results, the mean effective preconsolidation stress (p'_c) and corresponding OCR (OCR_p) were determined for sample no. 28, for which both oedometer and CIUC test results are available. The former is given by

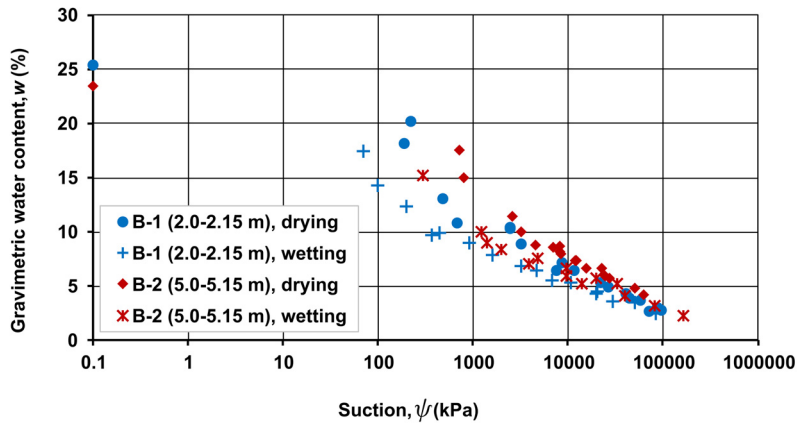
Figure 23. Results of SWRC measurements including drying and wetting paths plotted in the gravimetric water content versus the logarithm of the suction coordinate system (SWRC-w).

Results for samples no. 021 (B-1) and 030 (B-2), including drying and wetting paths, are depicted in Figures 23 and 24. In Figure 23, data are plotted in the gravimetric water
