Natural building stone in the construction and renovation of the Zagreb Cathedral

Rudarsko-geološko-naftni zbornik
(The Mining-Geology-Petroleum Engineering Bulletin)
UDC: 553.5; 622; 622.3
DOI: 10.17794/rgn.2023.3.3

Review scientific paper

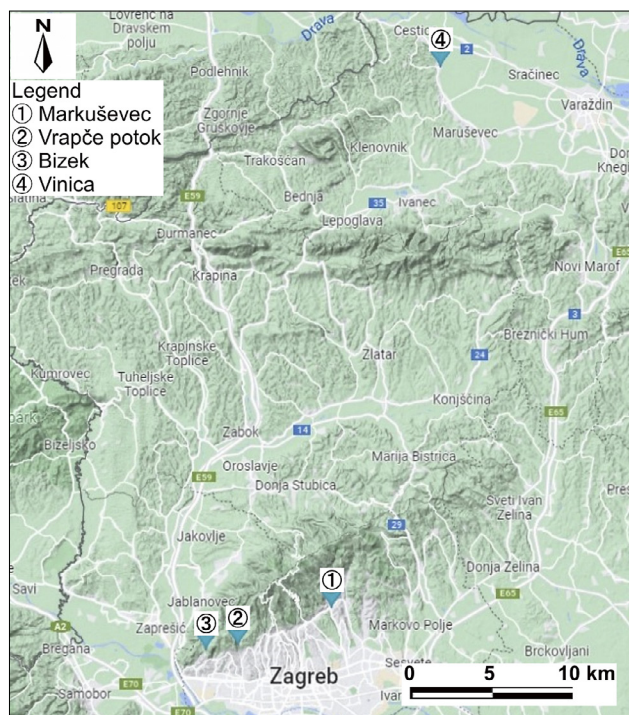
Figure 5: Locations of former quarries connected with the construction and renovation of the Zagreb Cathedral, on the map base at URL1

A literature review revealed four domestic quarries which were important for the construction of the Cathedral (see Figure 5): Markuševec, Vrapče potok, Bizek and Vinica. These sites were investigated in search of traces of a former quarry.
