# Origin of the stone varieties used in the cultural heritage buildings of Lumbarda, island of Korčula, Croatia

Source / Izvornik: Journal of Anthropological and Archaeological Sciences, 2020, 2, 279 - 286

Research Article

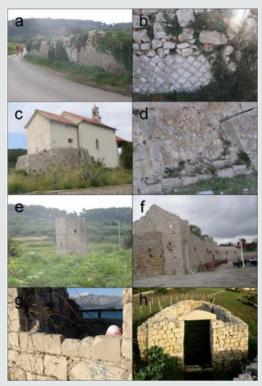
**Figure 2:** Figures of a) remains of Roman Villae Rusticae, that is b) made of small stone blocks, c) St Križ Church with d) visible apse of the old church, e) Venetian Tower, f) Bishop's Summer House, and g) southern wall of the House, h) remains of St Barbara Church on Sutvara islet (Photo of St Barbara church remains by N. Fazinić).

Many of the old buildings from Lumbarda, as Villae Rusticae building from Roman times and medieval summer houses and churches, were built of stone that was exploited from the quarries in Lumbarda and on the Škoji islets. Therefore, special attention is paid to five old buildings and building remains which represent the cultural heritage of Lumbarda. The oldest building in Lumbarda is Roman Villae Rusticae (Figure 2a), which is partly built in the technique of "opus reticulatum", mentioned by Radićin 1885 [19]. The small stone blocks, one side is 10 to 11 cm long, have a quadrangular face and are set at an angle (Figure 2b). The remains

of the walls of an ancient square elongated building with unusual span and its foundations seem to be composed of many rooms [20]. According to the locals, these were allegedly prison or dungeons erected by the Roman emperor Diocletian, the sworn persecutor of the Christians. These Christians, brought and imprisoned there, worked in nearby quarries [20]. Remains of Roman Villae Rusticae is the only Roman period building on the eastern part of Korčula island. On the St Križ Church (Križ means Cross in Croatian) (Figure 2c), that is surrounded with the vineyards, the year 1774 was engraved. Church was expanded and decorated in 1881, with lodge built in front of the church [20]. The church was built on the foundations of a much older church. Today the foundations of the apse of the old church are visible (Figure 2d).

Near the remains of Roman Villae Rusticae, at the distance of about 100 m, it is located the Venetian Tower, remains of it, (Figure 2e) surrounded by famous Lumbarda vineyards. We were unable to find the data in the literature on the history of its construction. It is assumed that Tower had a reconnaissance and defensive function and used as an observatory for the channel and shipping way between Pelješac peninsula and Korčula island.In addition, fifteen country complexes built between the 15th and 18th centuries, are located in Lumbarda [21]. Therefore, Lumbarda was the country destination of the bishops and nobles from the Town of Korčula in 17th and 18th centuries. The first preserved summer house belonged to the Bishop (Figure 2f) and it was built in the 15th century with its northern wall's "sprout" from the sea, and the southern ones (Figure 2g) located next to the vineyard [21]. Remains of small church of St Barbara are located on the islet of Sutvara(Figure 2h) [22,23]. Church is 8 m long and 4.5 m wide, with polygonal-hexagonal apse typical for Byzantine architecture of the 6th to 7th centuries in Asia Minor. The three-sided broken outer line of the apse floor plan is a crucial mark for its dating to the 6th century [23]. The way the church was built is typically late antique. The stone material was not carved with delicate tools, but it was roughly cut and selected from the guarry waste. The walls were thus made with two separate raised faces and strengthened by the abundant throwing of mortar and small sharp stone into the inner width. But more than the ignorance or negligence of the masons, it seems that on the islet where stonemasons worked even before the construction of the church, this can be explained by the late antique or early Christian efforts to plaster the walls. On the side walls, other parts were built in the "fishbone" style (Figure 3). Front door was oriented at the west and entrance lintel, 153 cm long and 26 cm high, had a cross in the middle of the face. This form is rare, according to known examples it dates mainly from the 9th to 11th century, so its appearance here is enigmatic [23]. The cult of St. Barbara was conceived in the early Christian East, and from Syria from the IV century it spread with the movements of the monastic orders. It reached the West in the 13th to 14th centuries. According to Skok[24], Sutvara is a Latin-Greek hybrid toponym, which contains
